Muck Creek Watershed Restoration Strategy

Prepared for Nisqually River Foundation

Prepared by
Anchor QEA
1201 3rd Avenue, Suite 2600
Seattle, Washington 98101

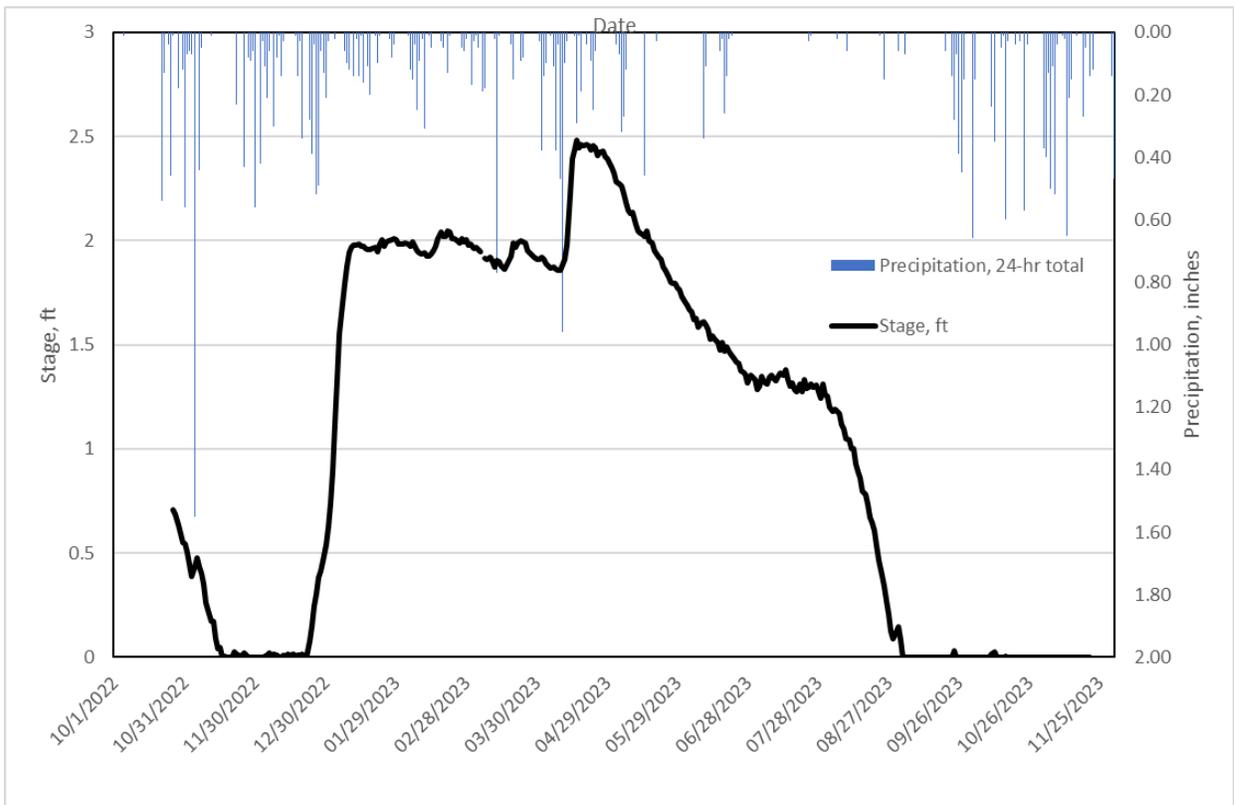
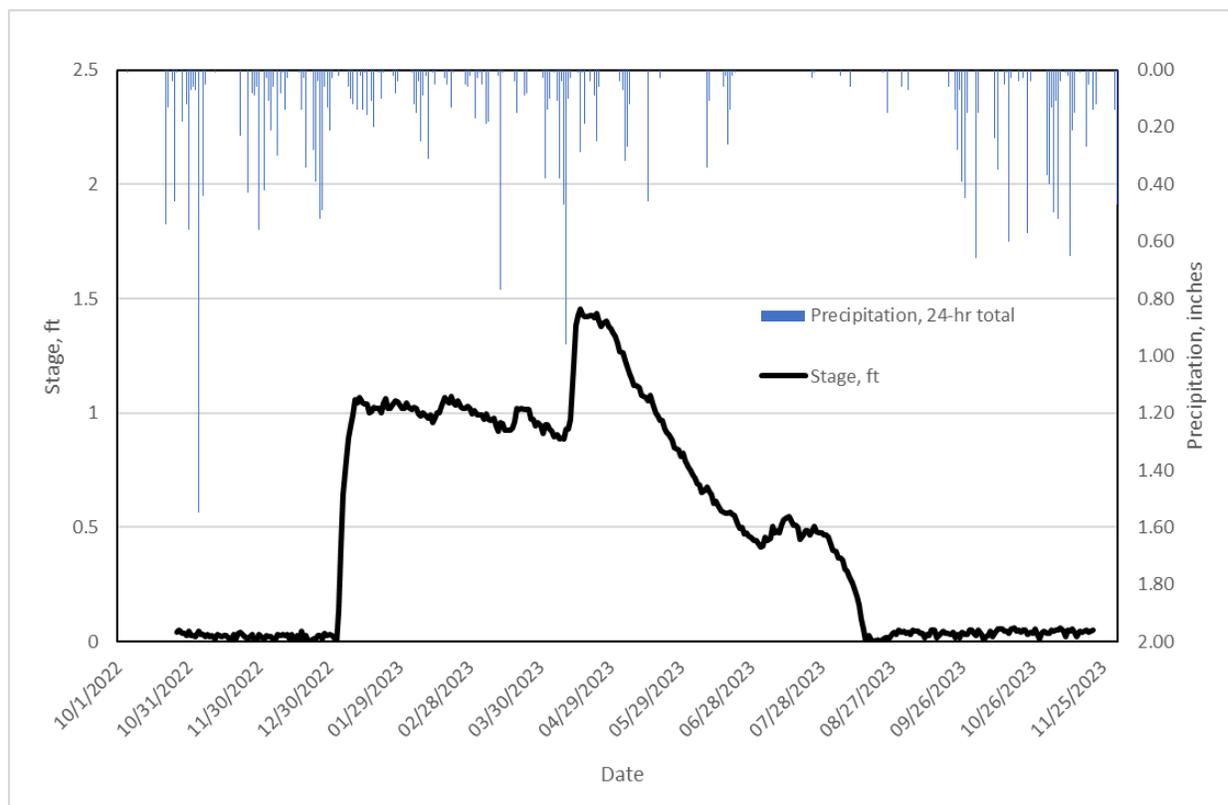
Figure 7
Chambers Lake Upstream Stage Hydrograph

Figure 8
Chambers Lake Downstream Stage Hydrograph

The water level in Chambers Lake varied by over 2.5 feet during the period of time monitored (Figures 7 and 8). The water level gages were installed in mid-September 2022, which was expected to be the time of lowest stage in the lake. However, water levels continued to drop below the level that the water level sensor was installed, so readings between late October and late December are not available. Water levels rose in late December above the sensors allowing recording of water levels until late August 2023 when they dropped again below the water level sensors.

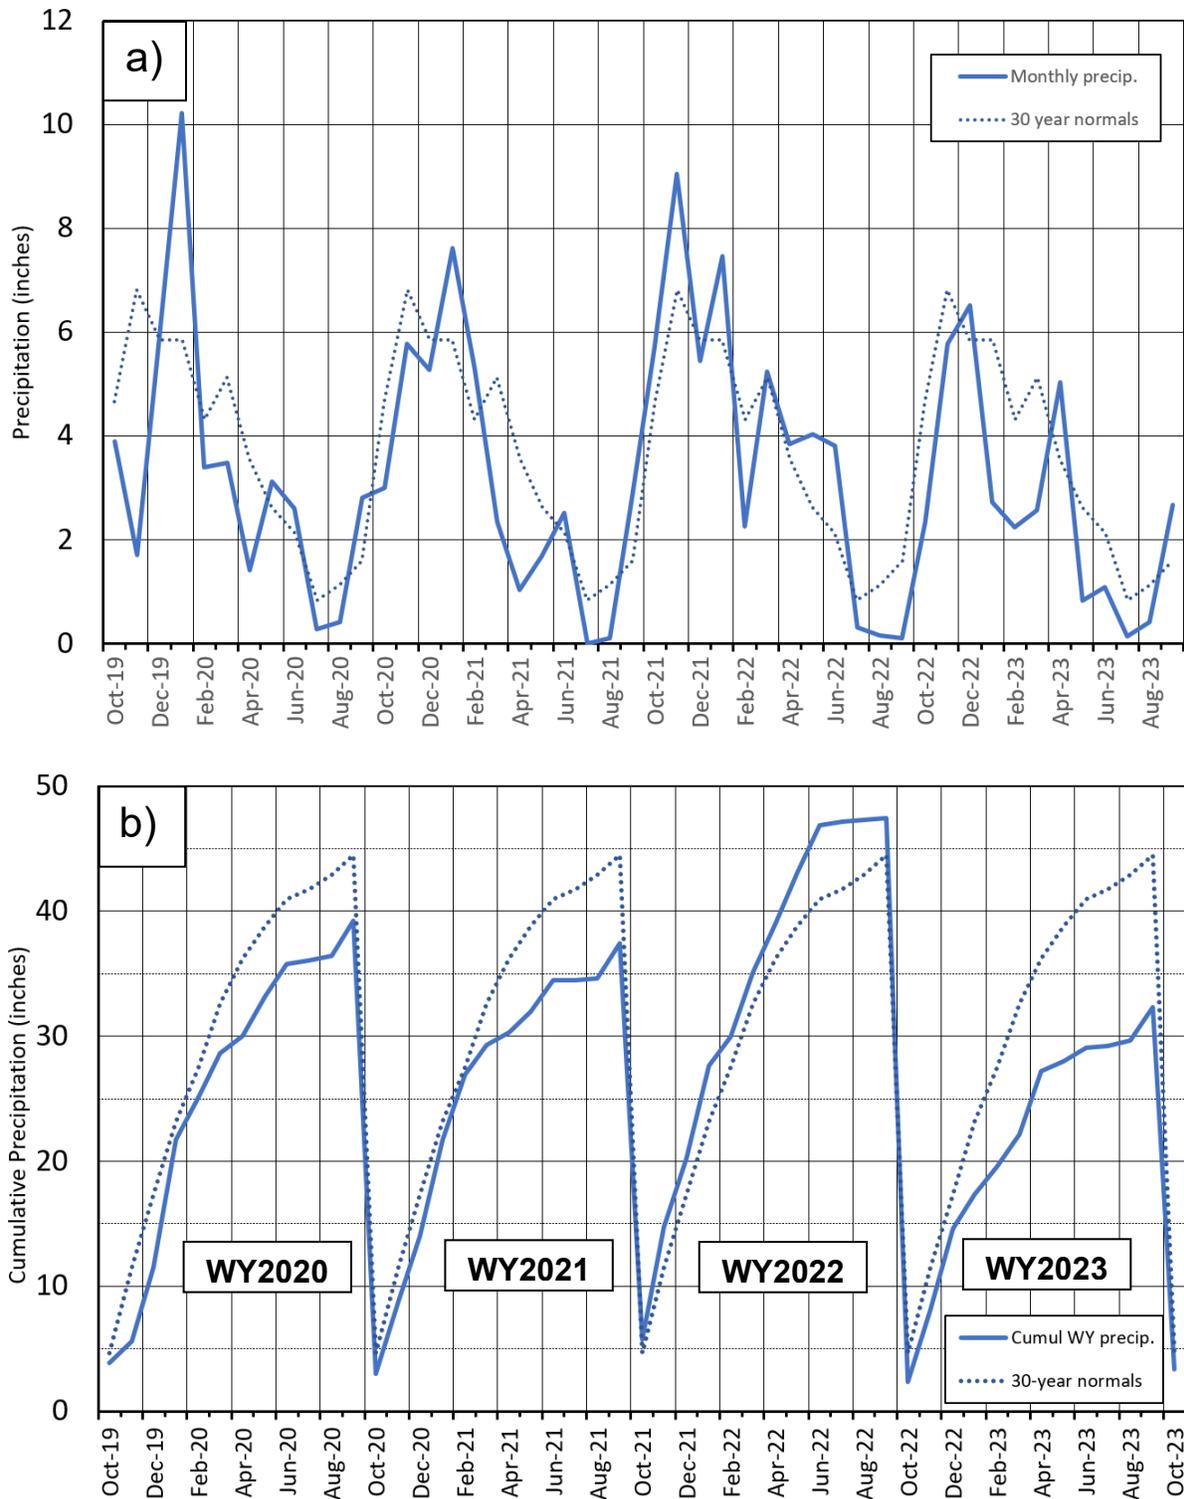
Figure 3: Precipitation estimated by PRISM for Muck Basin for recent water years: a) Monthly estimates. b) Cumulative water year.

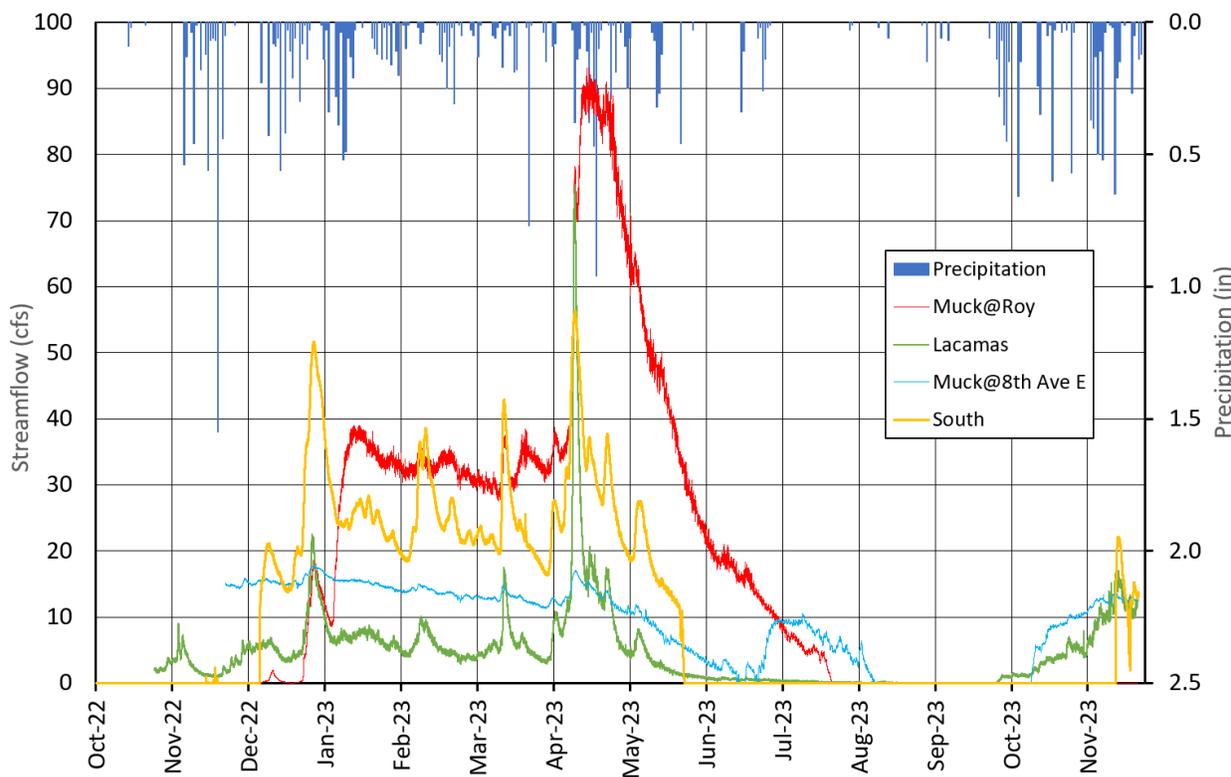
Figure 4: Stream discharge from Anchor gages.
(Inverse scale on righthand axis is for precipitation bars.)

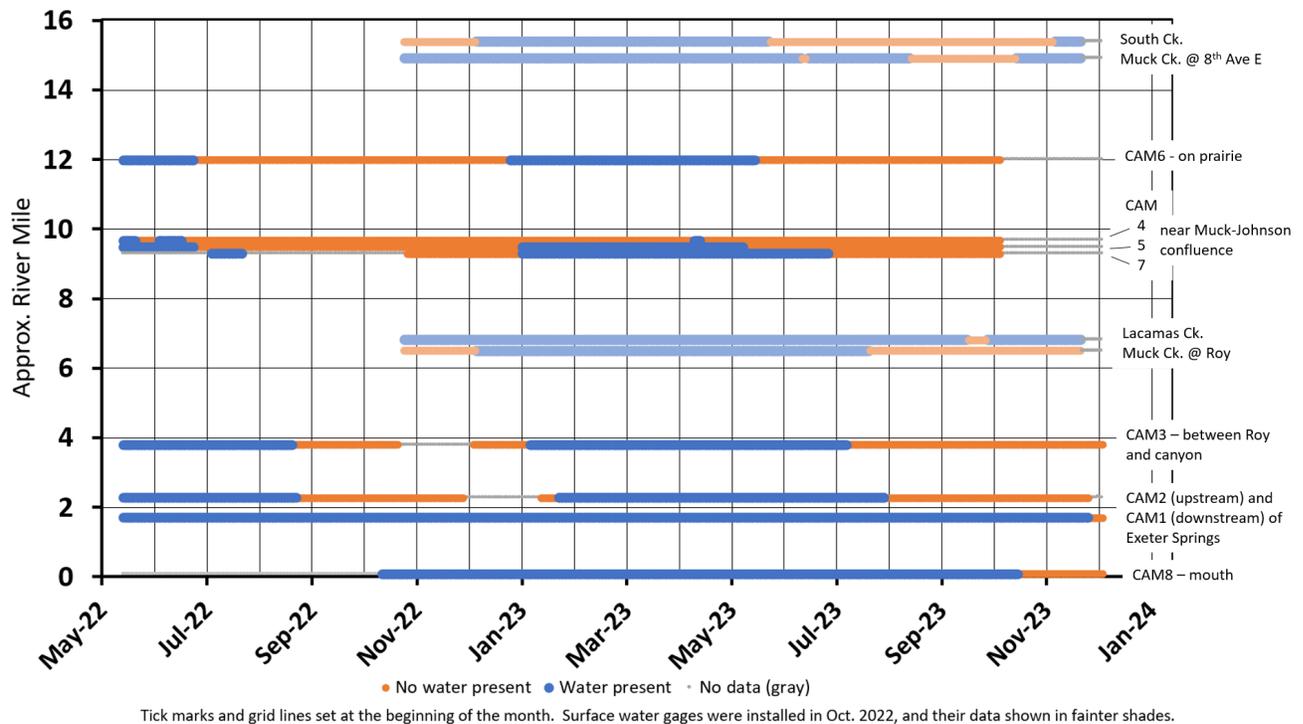
Figure 5: Presence and absence of water at all cameras and gages.

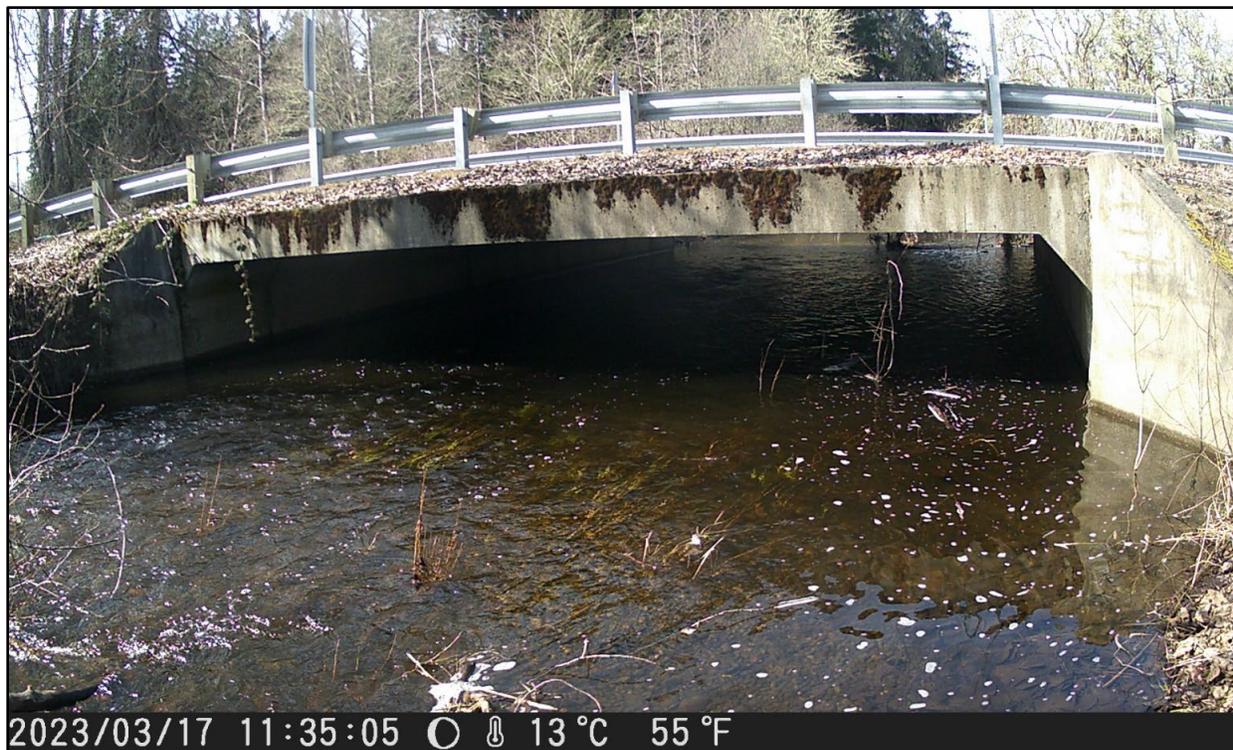
Figure 6: Muck Creek at CAM6 on 17 March 2023, looking downstream. Water depth estimated at 1.5+ feet.

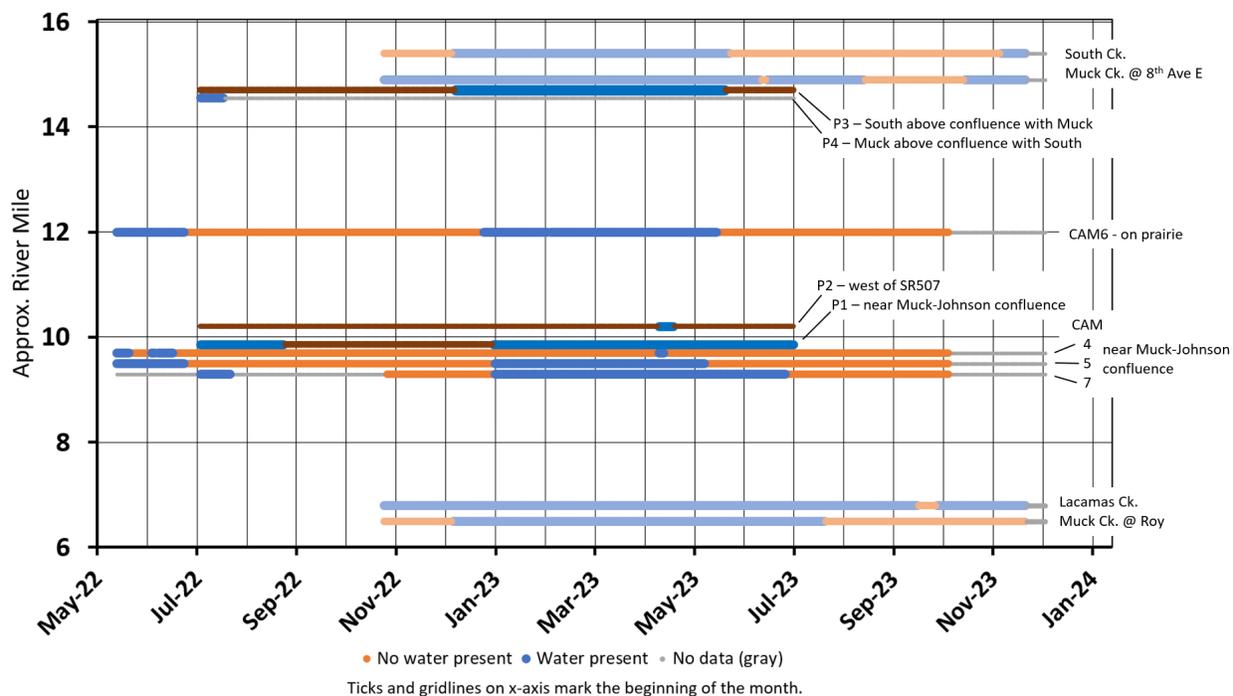
Figure 7: Presence and absence of water at cameras, piezometers, and gages at and above Roy.

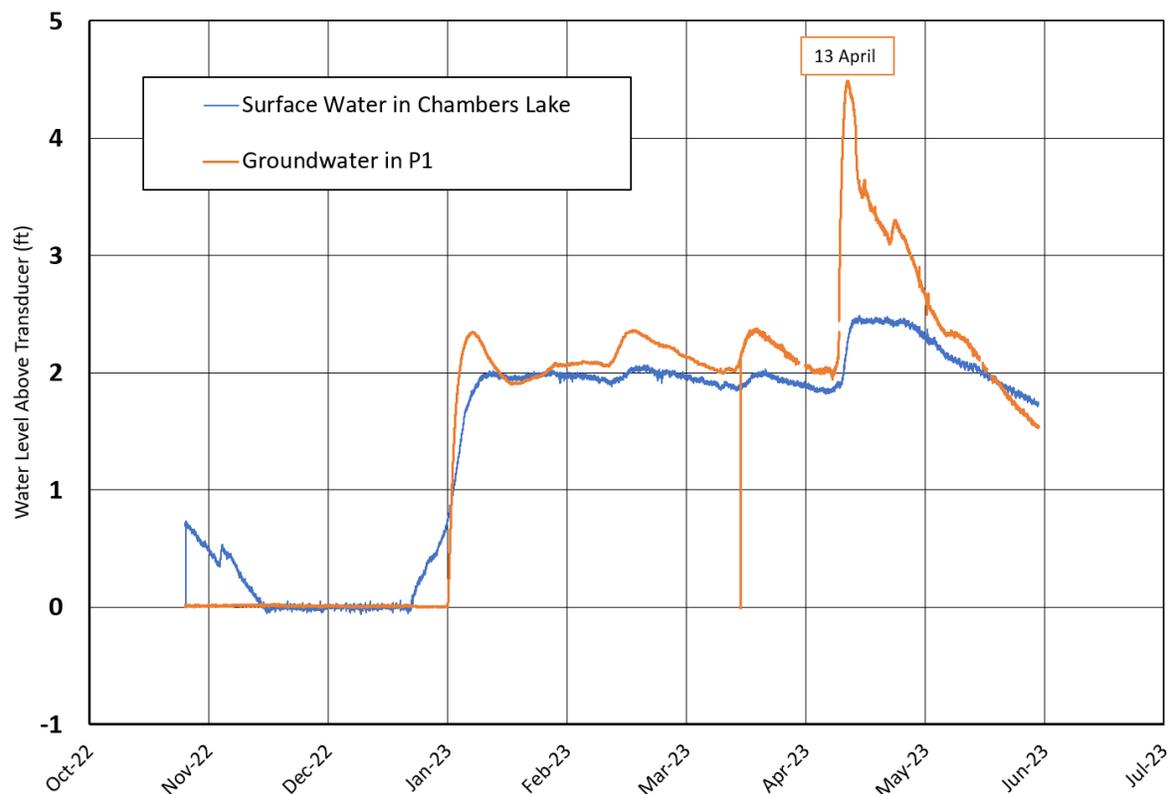
Figure 8: Comparison of groundwater levels in P1 with stage in Chambers Lake.
(Data sets are not to the same datum. Ticks on the x-axis are placed at the beginning of each month.)

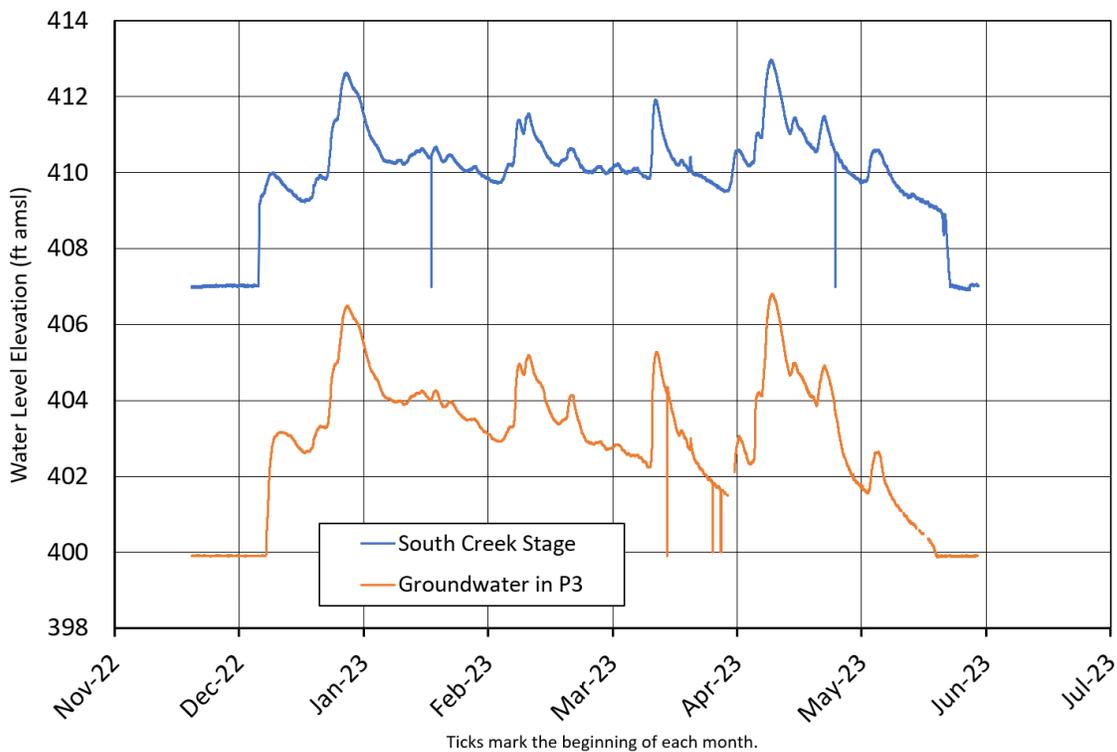
Figure 10: Comparison of groundwater levels in P3 with stage at South Creek gage.

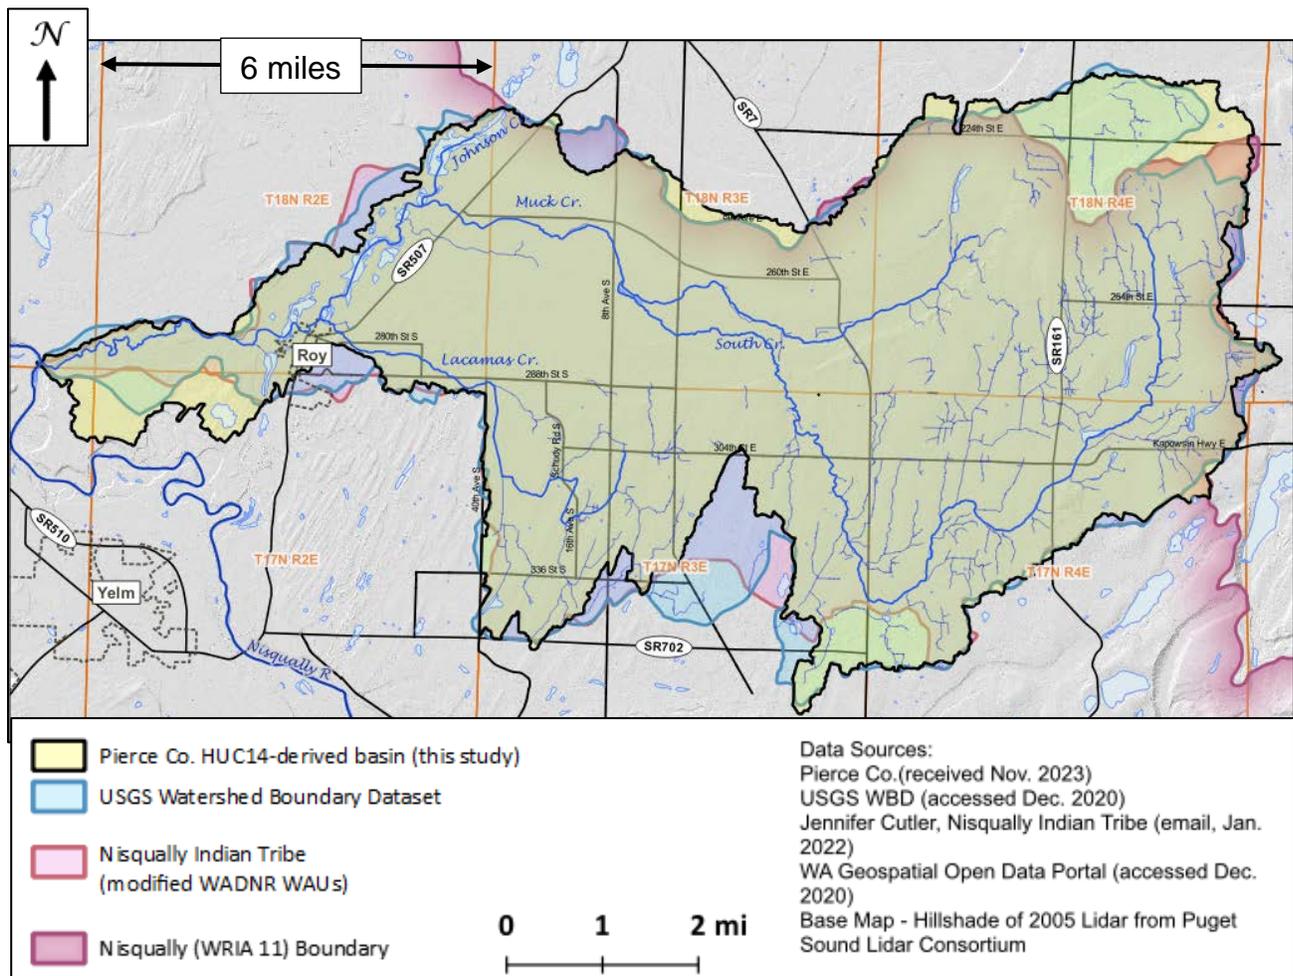
Figure 1: Basin delineation for this study compared to other versions.

For this work we use a boundary for the Muck Basin based on the work of the Pierce Co. Surface Water Management Division (SWMD) that expands upon the USGS HUC delineations (Figure 1). The SWMD is nearing completion of this project and shared their draft results for Muck Basin with us (Pierce Co. SWM, 2023). This work is consistent with the lidar-based stream network layer created by the SWMD and used in this project.

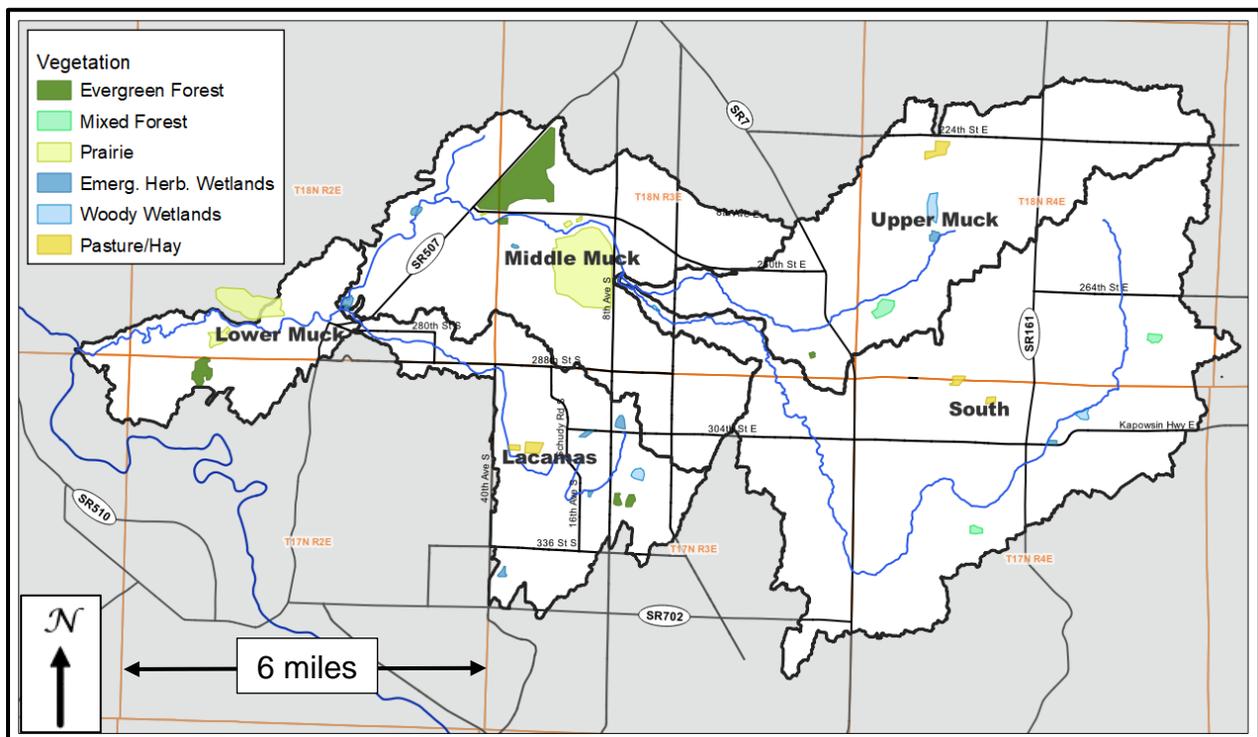
Figure 2: Representative areas of common vegetation sampled in OpenET.

For the late 1800s, the ET of the prairie and evergreen forest were assumed to be equivalent to the prairie and evergreen forest areas sampled in OpenET. The wetlands were assumed to be 75% woody wetlands and 25% herbaceous wetlands.

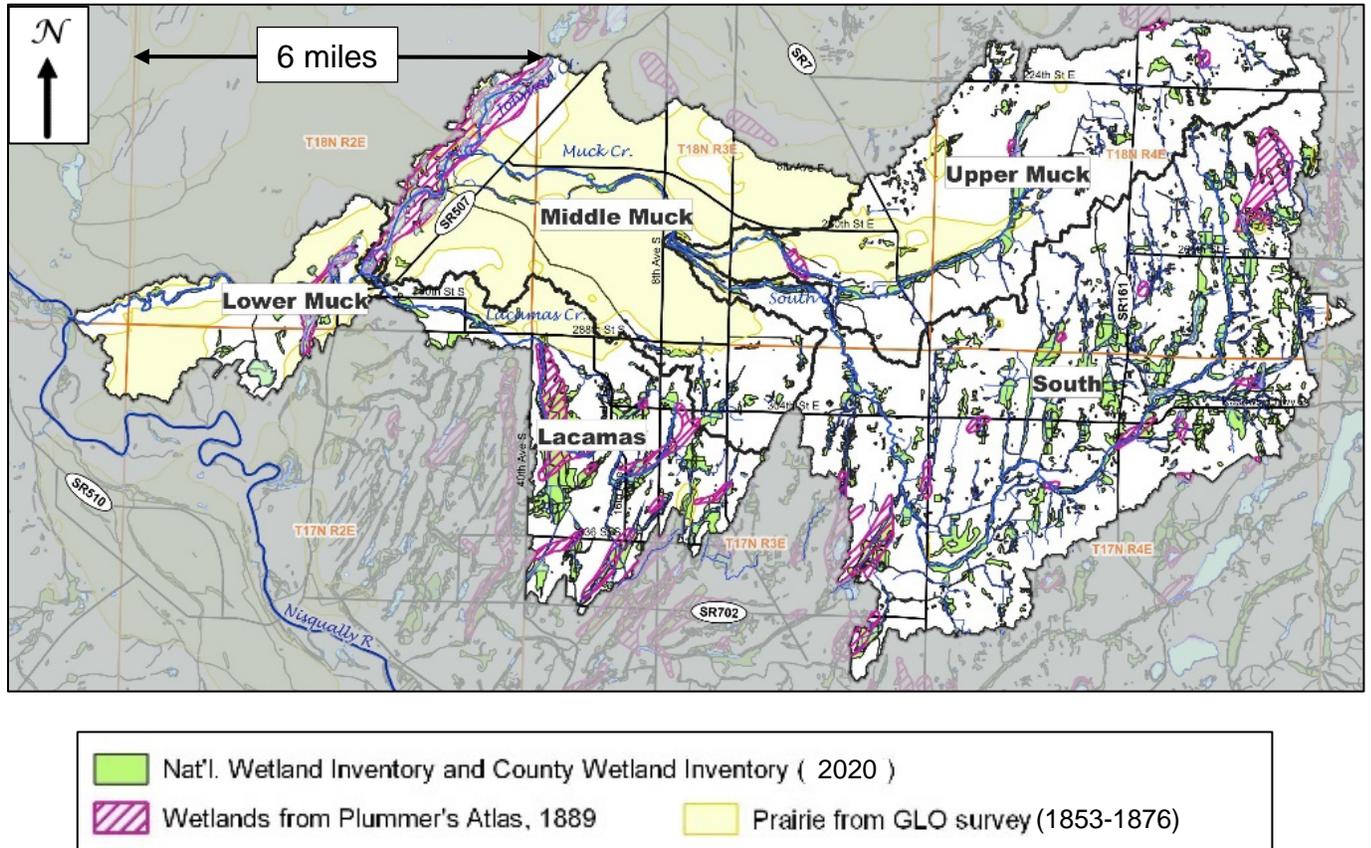
Figure 5: Wetland distributions according to different sources.

more but generally smaller wetlands along stream corridors (Figure 5). In the Middle Muck Subbasin only, the area and location of the Plummer’s (1889) wetlands and the combined NWI-CWI wetlands are similar. In all other basins, the area of wetlands mapped by Plummer (1889) is less than half of that mapped by the NWI and CWI. According to the NWI and CWI, approximately 25% of Lacamas Creek subbasin and 20% of South Creek subbasin are covered by possible wetlands. Lower, Middle, and Upper Muck Creek Subbasins all have less than 10% wetland coverage.

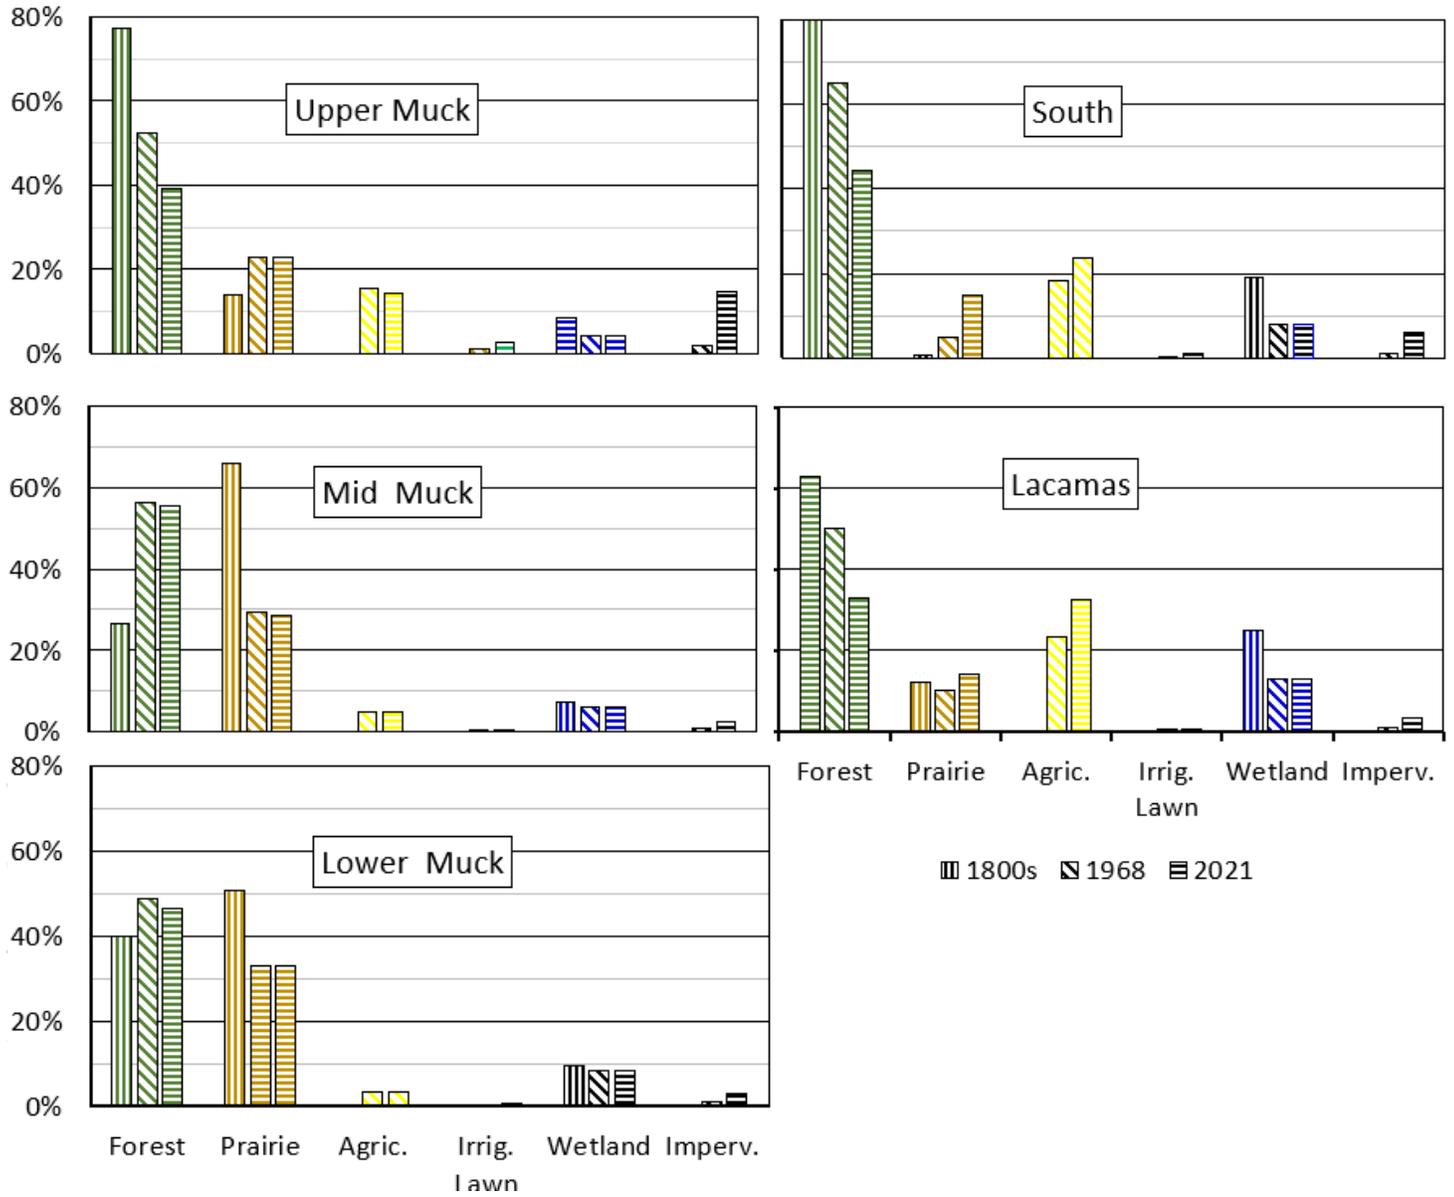
Figure 8: Estimated vegetation types over time.

The residential areas are mostly in areas formerly covered by forest but also on formerly agricultural lands. Compared to conditions in 1968, agricultural fields, primarily for pasture or hay, have expanded in Lacamas and South subbasins at the expense of forested land. The extent of agricultural fields has stayed roughly constant in the Upper Muck Subbasin. Forested areas have decreased in Upper Muck, Lacamas, and South subbasins.

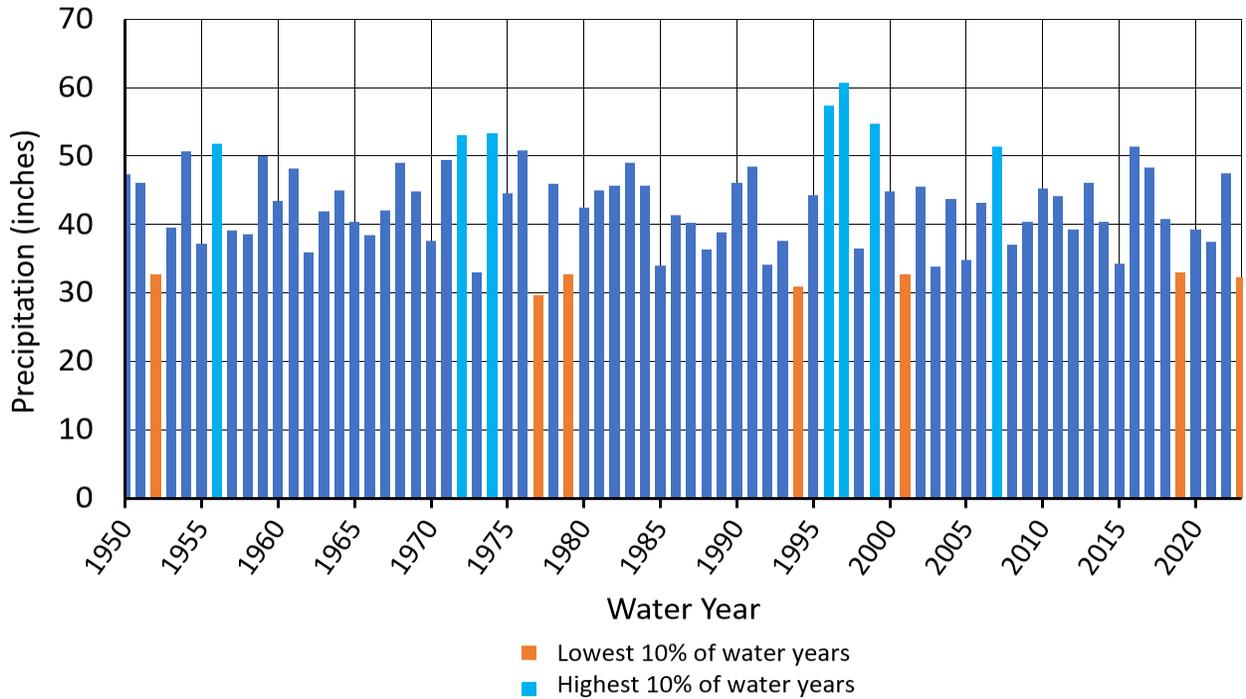
Figure 12: Water year precipitation, 1950-2023.

The last five water years (2019-2023) average 38 inches and contain two years that are in the lowest 10% of precipitation for the past 70 years (Figure 12).

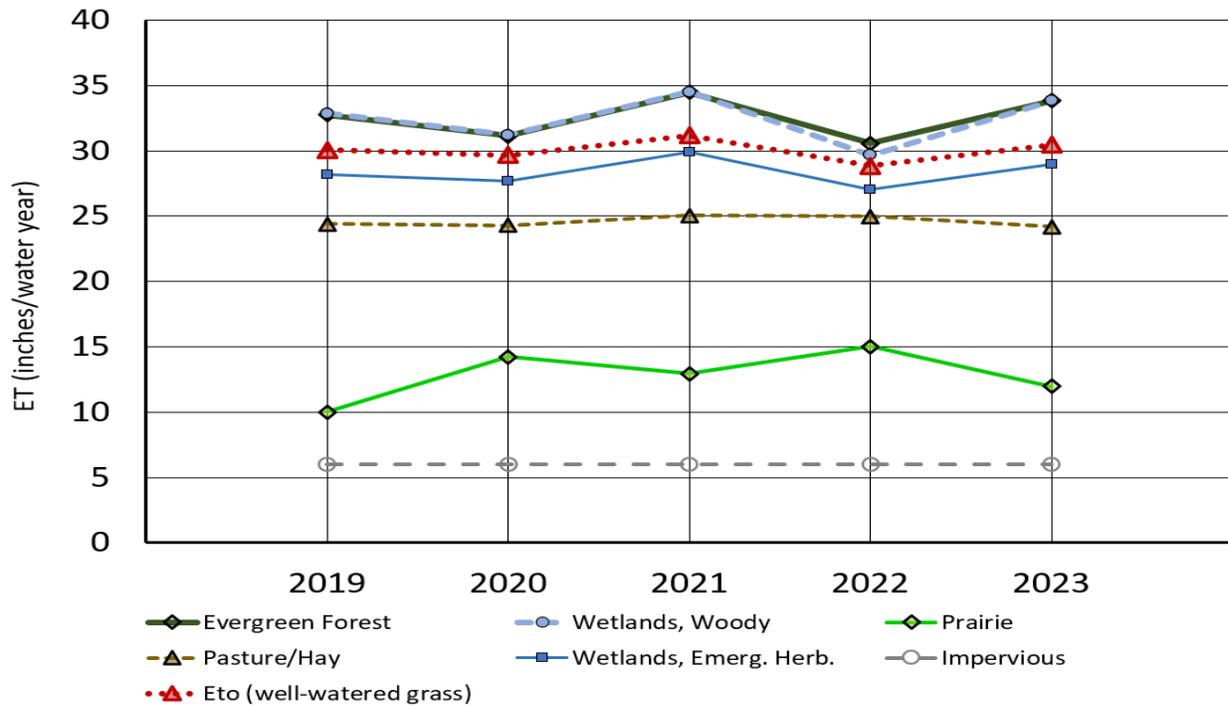
Figure 13: OpenET estimates of water-year ET for major vegetation types.

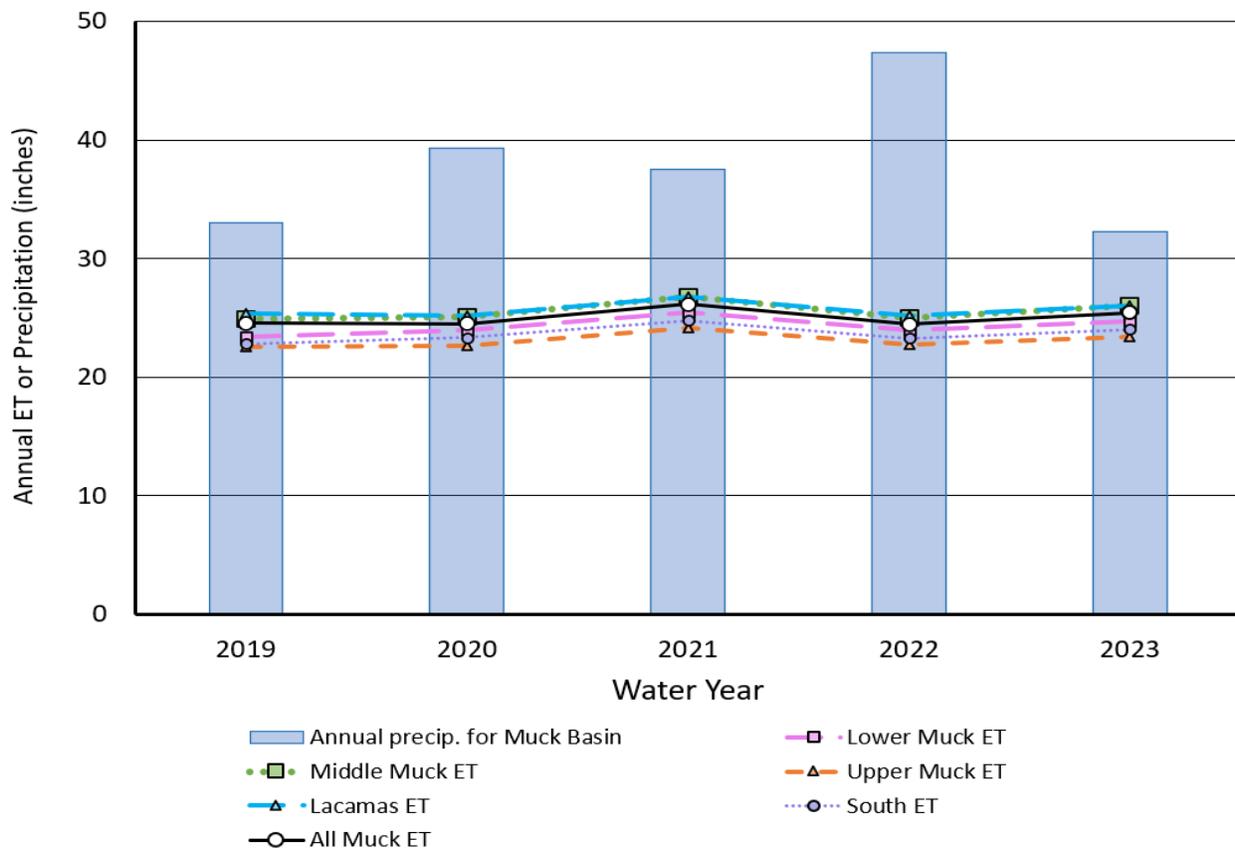
Figure 15: OpenET estimates by subbasin.

Subbasin	Late 1800s	1968	2021	Late 1800s-2021 Change
Lower Muck	22.4"	24.9"	24.3"	8%
Middle Muck	19.5"	25.8"	25.6"	31%
Upper Muck	29.7"	26.1"	23.1"	-22%
Lacamas	29.8"	28.4"	25.7"	-14%
South	32.2"	29.6"	23.7"	-26%
Whole Basin	27.9"	27.6"	24.3"	-13%

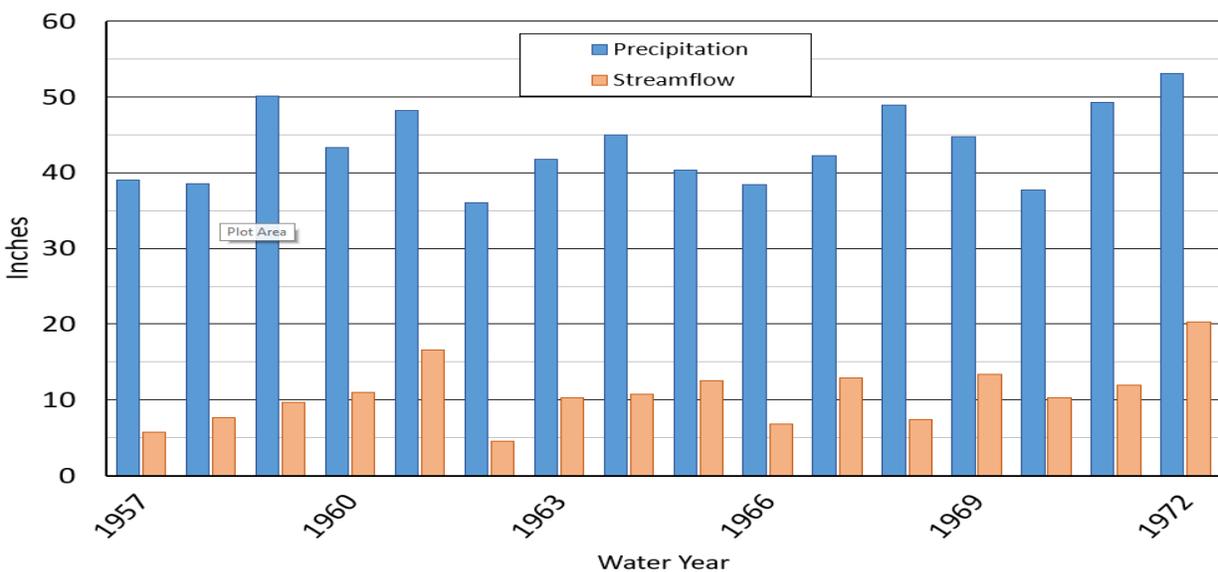
Figure 17: Precipitation across basin vs. streamflow at Roy, WYs 1957-1972.

The most complete record of streamflow was collected from 1957-72 when the basin had much less residential development. At that time, streamflow upstream of the Roy gage averaged 10.7” per water year, ranging from a low of 4.5” in 1962 to a high of 20.3” in 1972 (Figure 17). A flow control device was installed at the mouth of Chambers Lake in 1967. This location is upstream of the Roy gage, and the device may have affected streamflow measurements at Roy after that time.

Over the period of 1957-72 streamflow at Roy was 13% to 38% of precipitation. None of these water years had precipitation totals in the lowest 10% of water years. The months with the highest streamflows were January and February, with more variability than in precipitation record (Figure 11 and Figure 18). A comparison of the monthly averages of precipitation and streamflow shows a temporal lag of about a month in streamflow relative to precipitation (Figure 19). This pattern reflects the need to fill soil moisture capacity and groundwater “reservoirs” at the end of the dry season before significant surface water flow is generated.

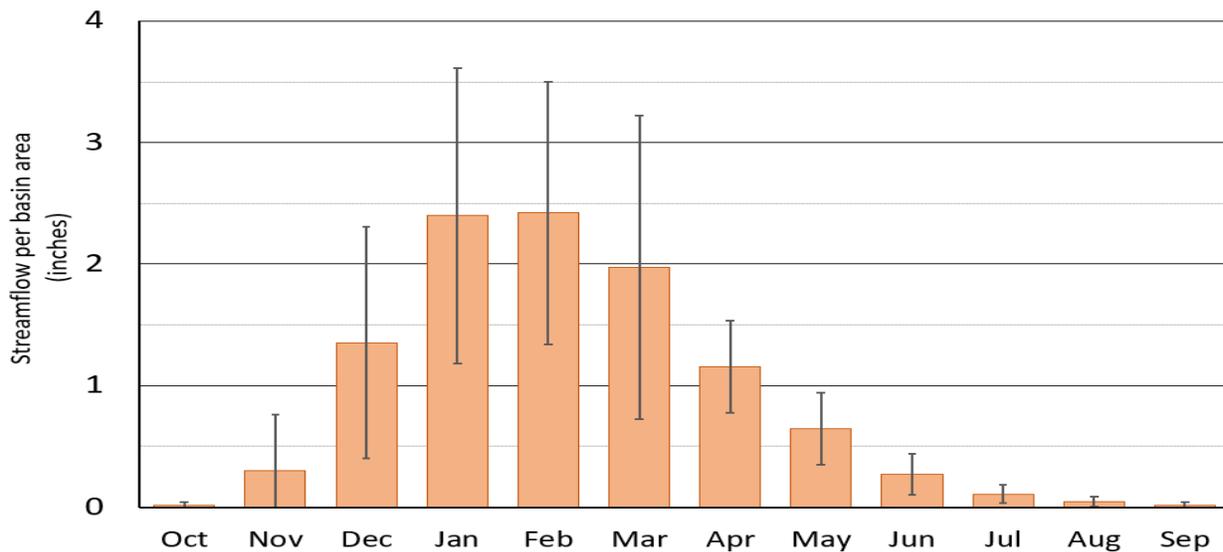
Figure 18: Monthly streamflow at Roy (1956-1972; means and standard deviations).

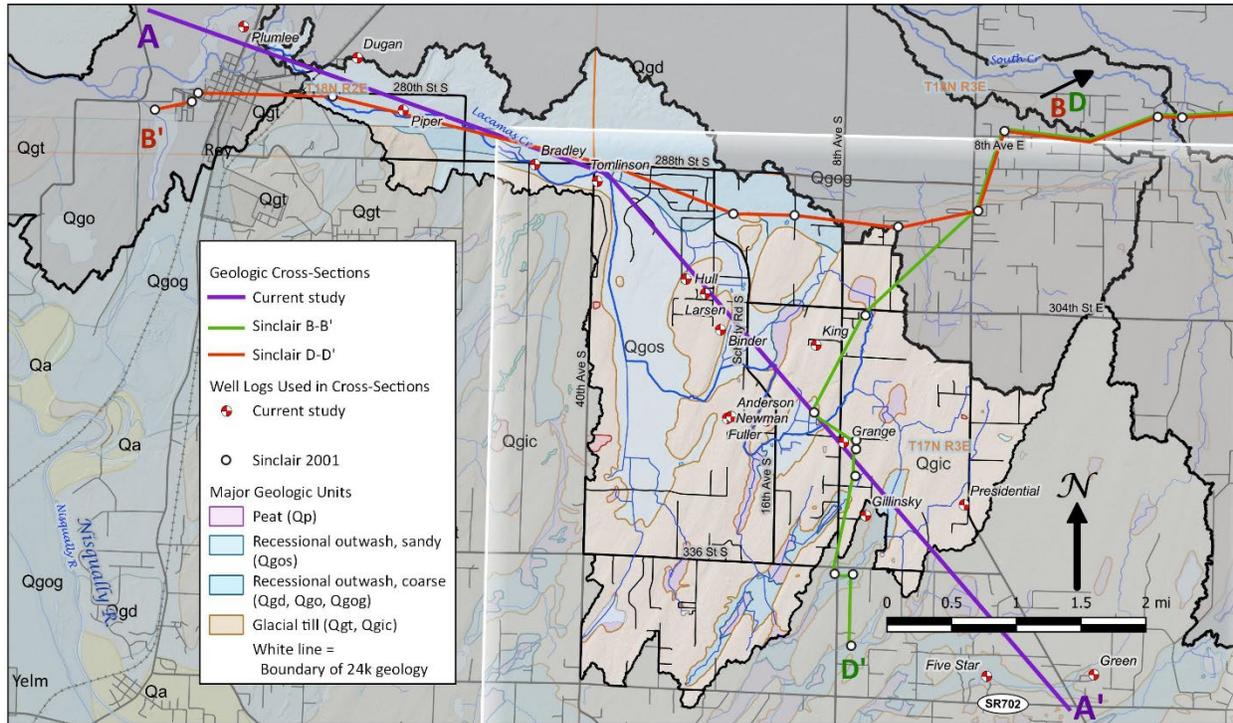
Figure 7: Surficial geology and location of cross-sections.

to oldest (Figure 7). The descriptions and geologic map include the symbols used by Contreras and others (2023), which is the most recent and detailed mapping of the study area:

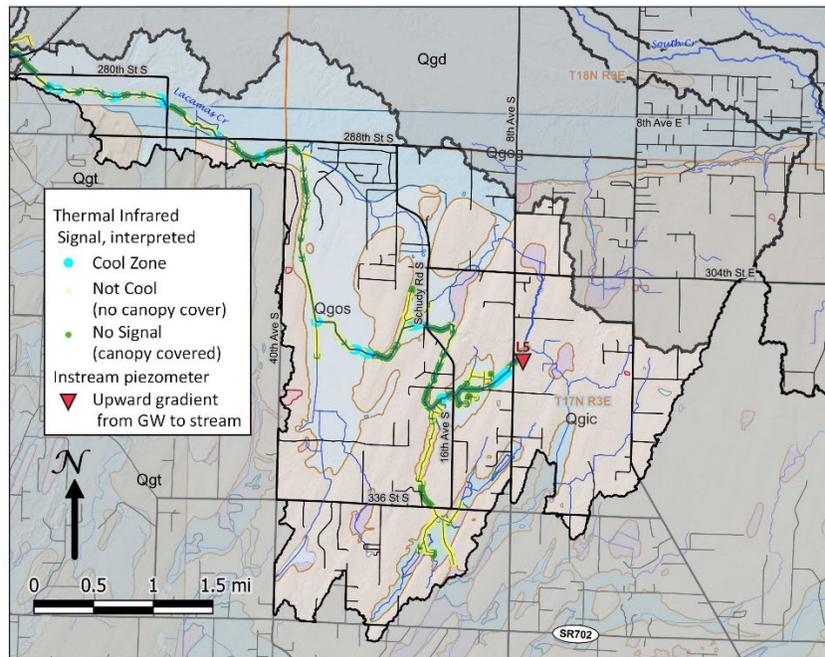
Figure 9: Possible zones of groundwater input to Lacamas Creek from TIR survey

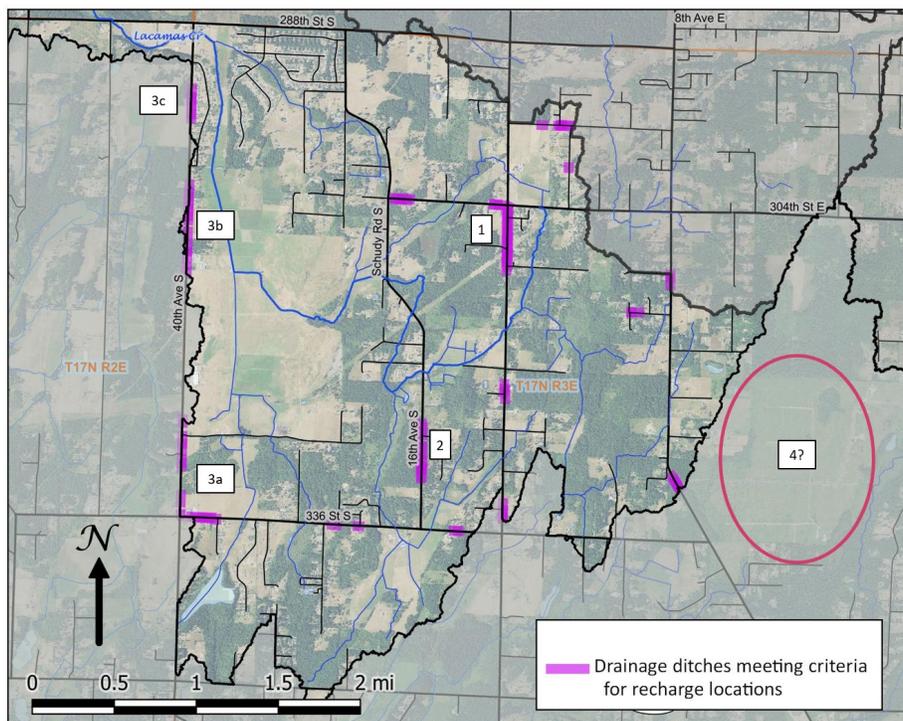
Figure 10: Locations of drainage ditches meeting criteria for possible enhanced recharge.

1. 8th Ave S between 304th St and 310th St
2. 16th Ave S near 327th St
3. 40th Ave S. (several sections) on west edge of Lacamas Subbasin. From north to south:
 - a. Between 328th St and 336th St., as well as areas on 336th St.
 - b. At same latitude as 304th to 314th St.
 - c. At same latitude as 296th St
