Muck Creek Watershed Restoration Strategy

Prepared for Nisqually River Foundation

Prepared by
Anchor QEA
1201 3rd Avenue, Suite 2600
Seattle, Washington 98101

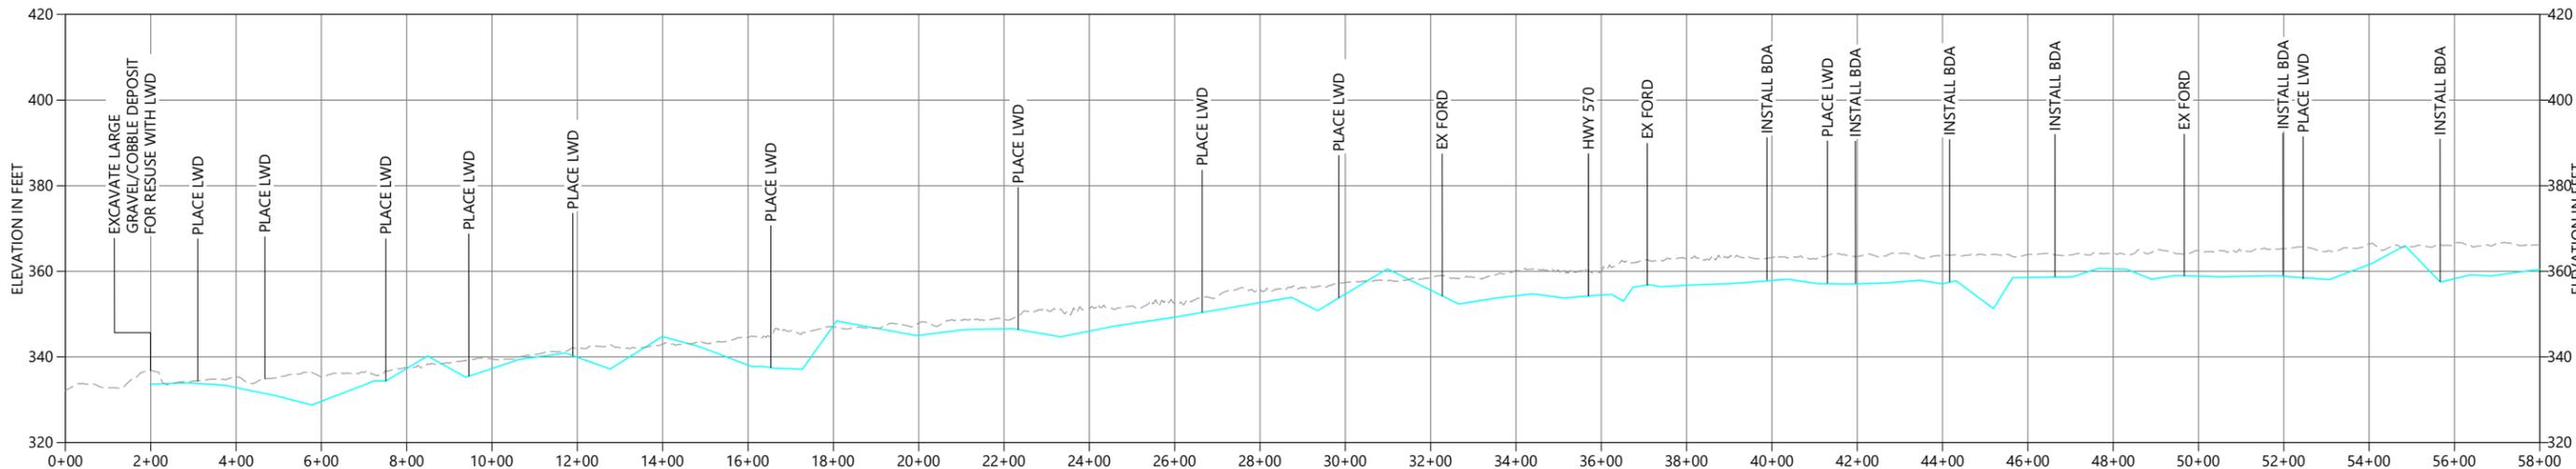
STREAM PROFILE, STATION 0+00 TO 58+00
 HORIZONTAL SCALE: 1" = 200'
 VERTICAL SCALE: 1" = 20'

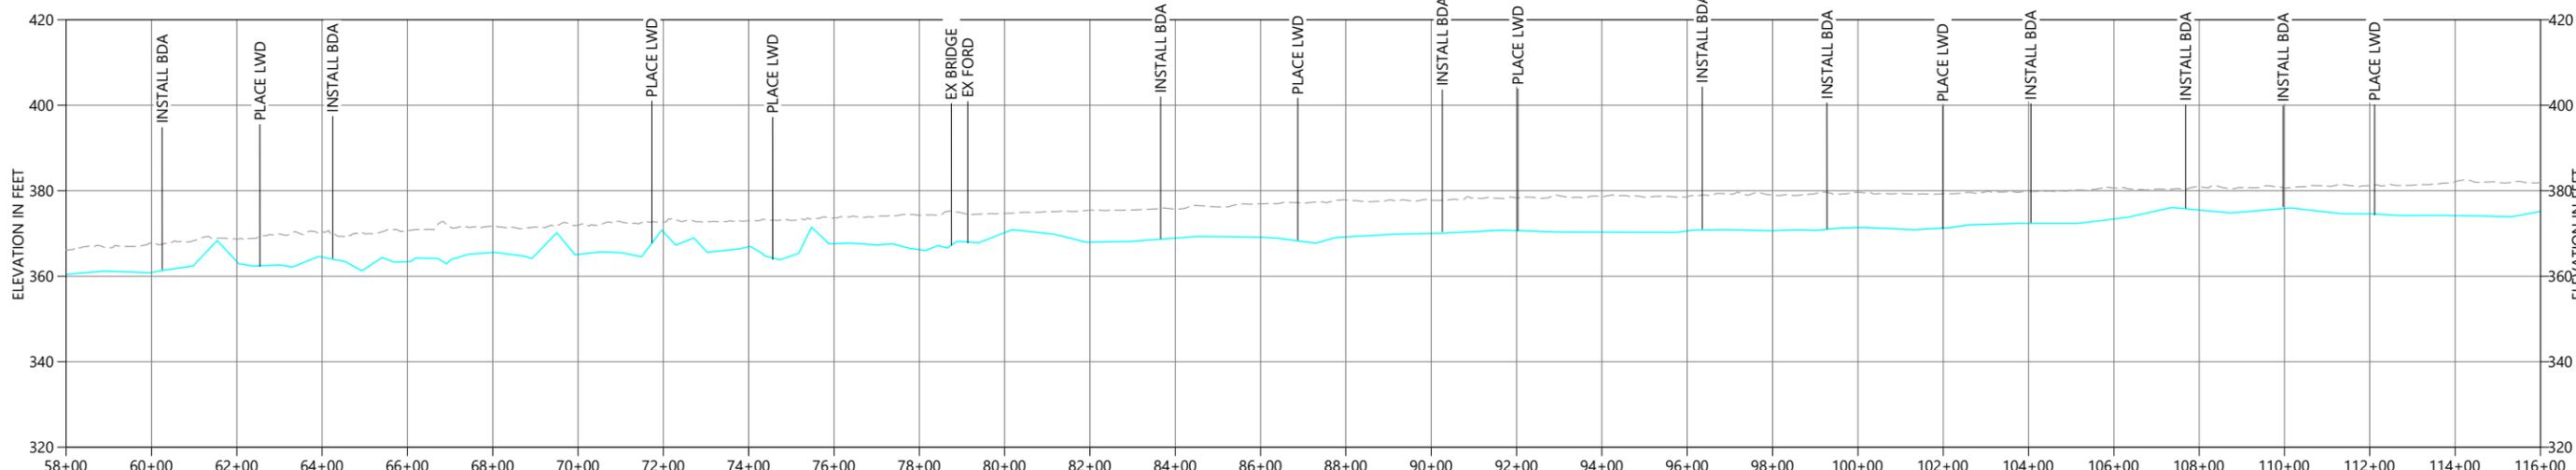
STREAM PROFILE, STATION 58+00 TO 116+00
 HORIZONTAL SCALE: 1" = 200'
 VERTICAL SCALE: 1" = 20'

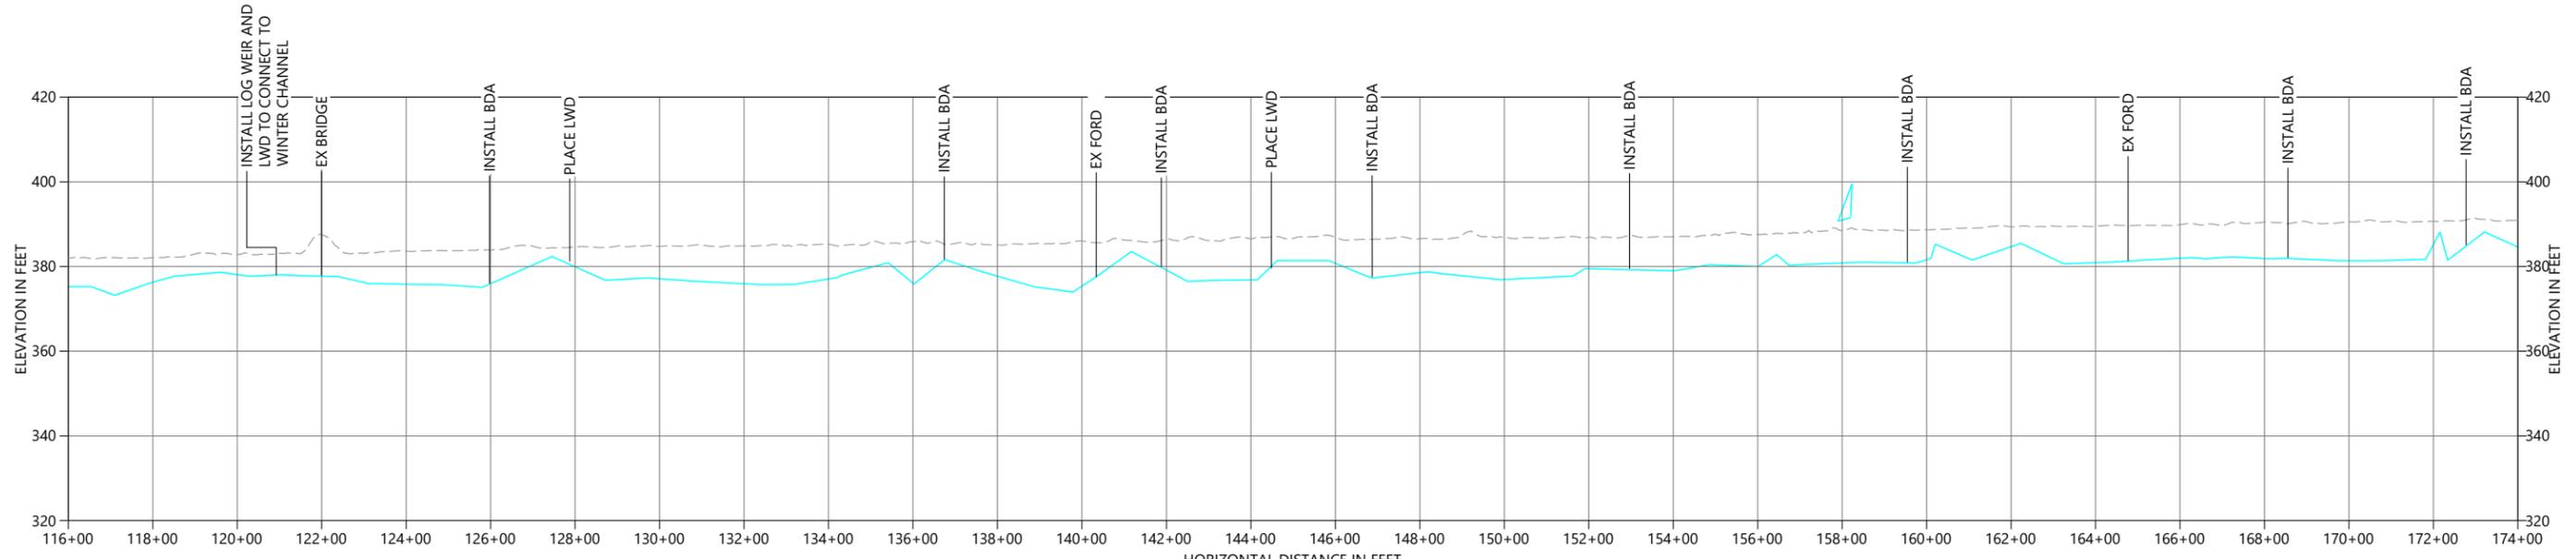
STREAM PROFILE, STATION 116+00 TO 174+00
 HORIZONTAL SCALE: 1" = 200'
 VERTICAL SCALE: 1" = 20'

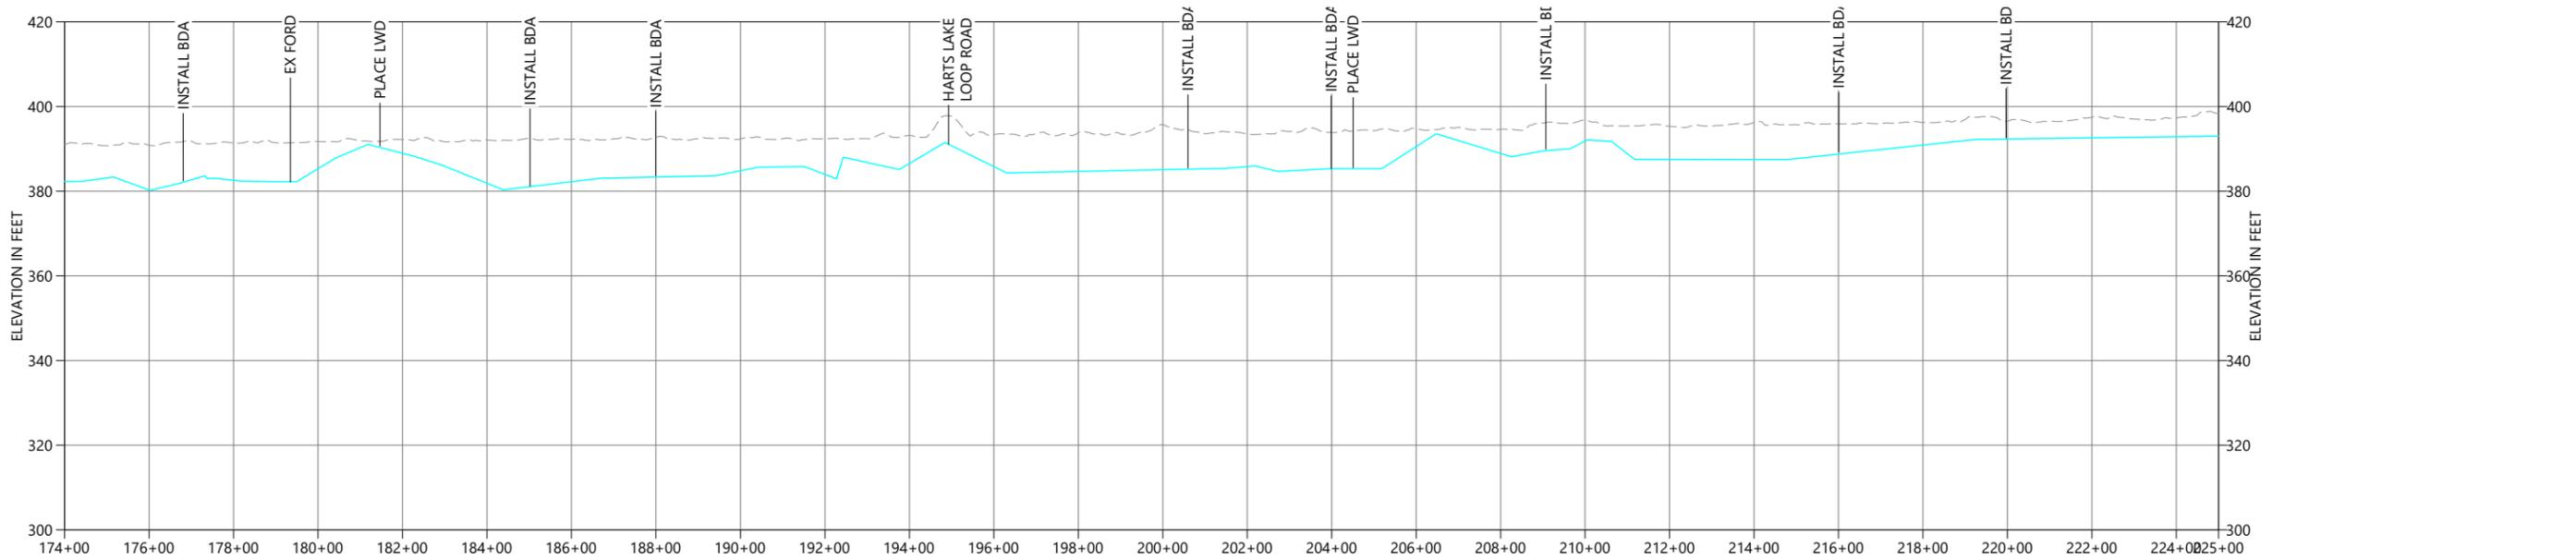
STREAM PROFILE, STATION 174+00 TO 225+00
 HORIZONTAL SCALE: 1" = 200'
 VERTICAL SCALE: 1" = 20'

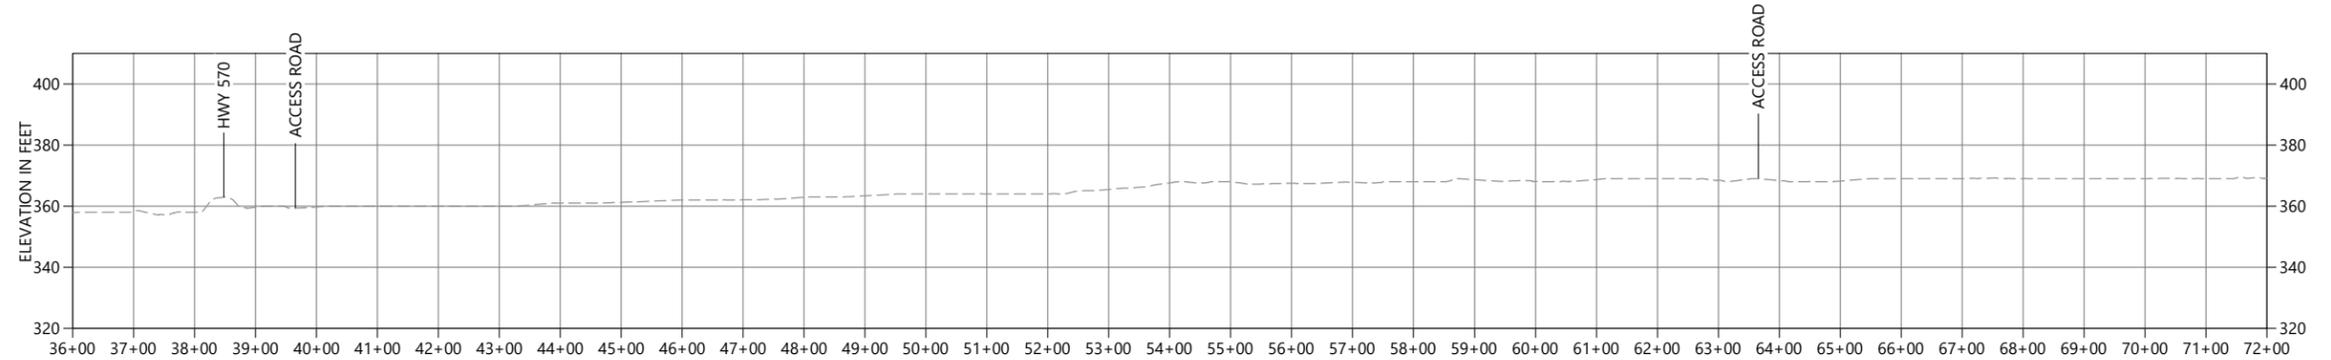
WINTER CHANNEL PROFILE, STATION 36+00 TO 72+00
 HORIZONTAL SCALE: 1" = 150'
 VERTICAL SCALE: 1" = 30'

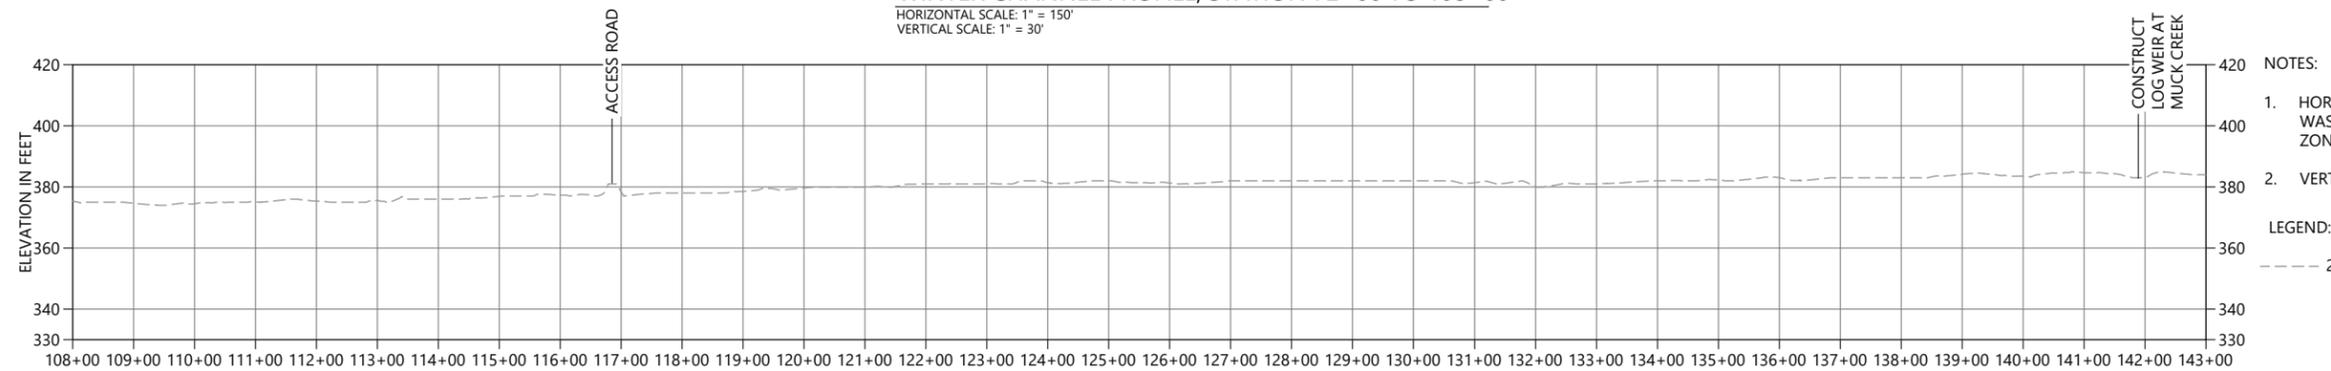
WINTER CHANNEL PROFILE, STATION 108+00 TO 143+00
 HORIZONTAL SCALE: 1" = 150'
 VERTICAL SCALE: 1" = 30'

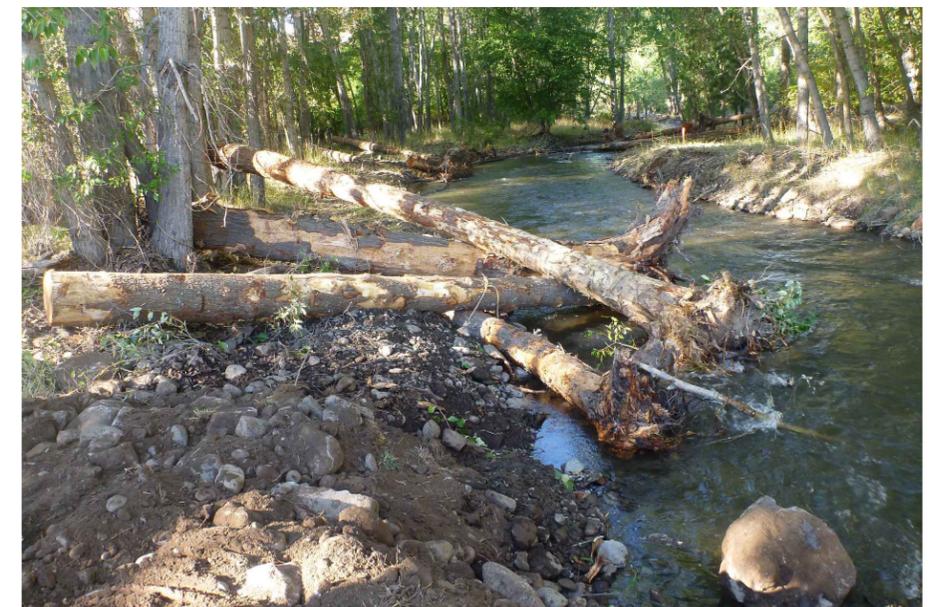
EXAMPLE LARGE WOOD CLUSTER

8. CONTRACTOR SHALL COORDINATE WITH RE-VEGETATION CREWS FOR INSTALLATION OF PLANTS. PLANTS WILL BE INSTALLED BY OTHERS WITHIN AND AROUND THE STRUCTURE NEAR THE GROUNDWATER LEVEL. CARE SHALL BE TAKEN NOT TO DAMAGE PLANTINGS INSTALLED PRIOR TO COMPLETION OF THE STRUCTURE.

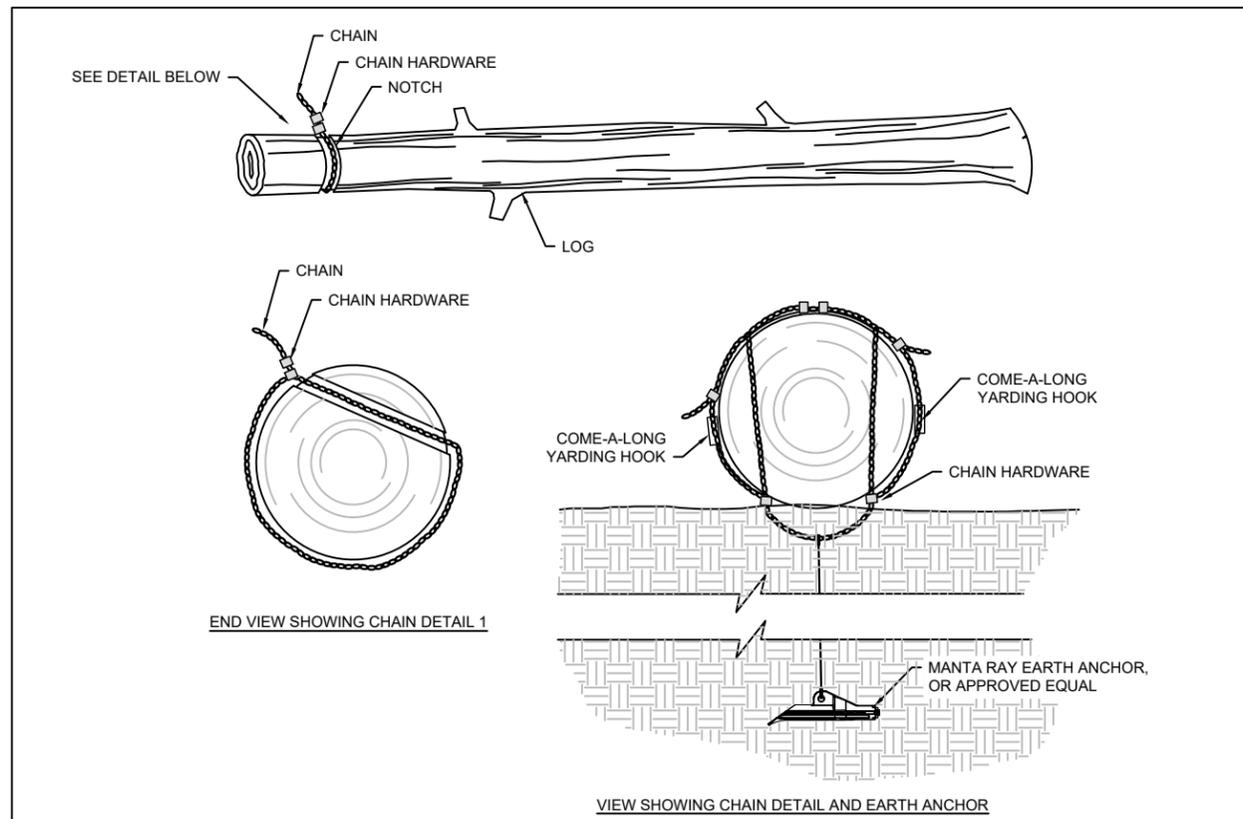
2 MANTA RAY ANCHOR INSTALLATION DETAIL
C-09 SCALE: 1" = 2'

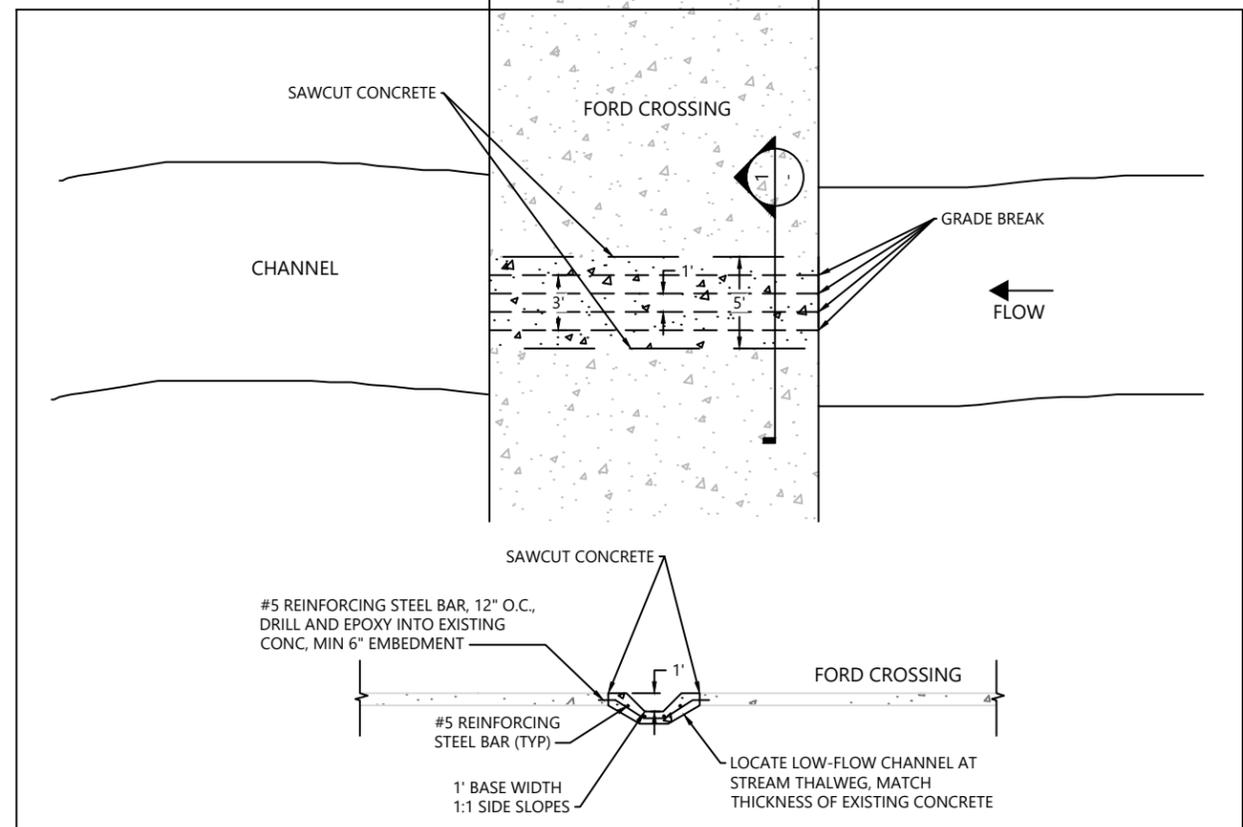
1 FORD CROSSING LOW-FLOW CHANNEL DETAIL
C-02 SCALE: 1" = 5'

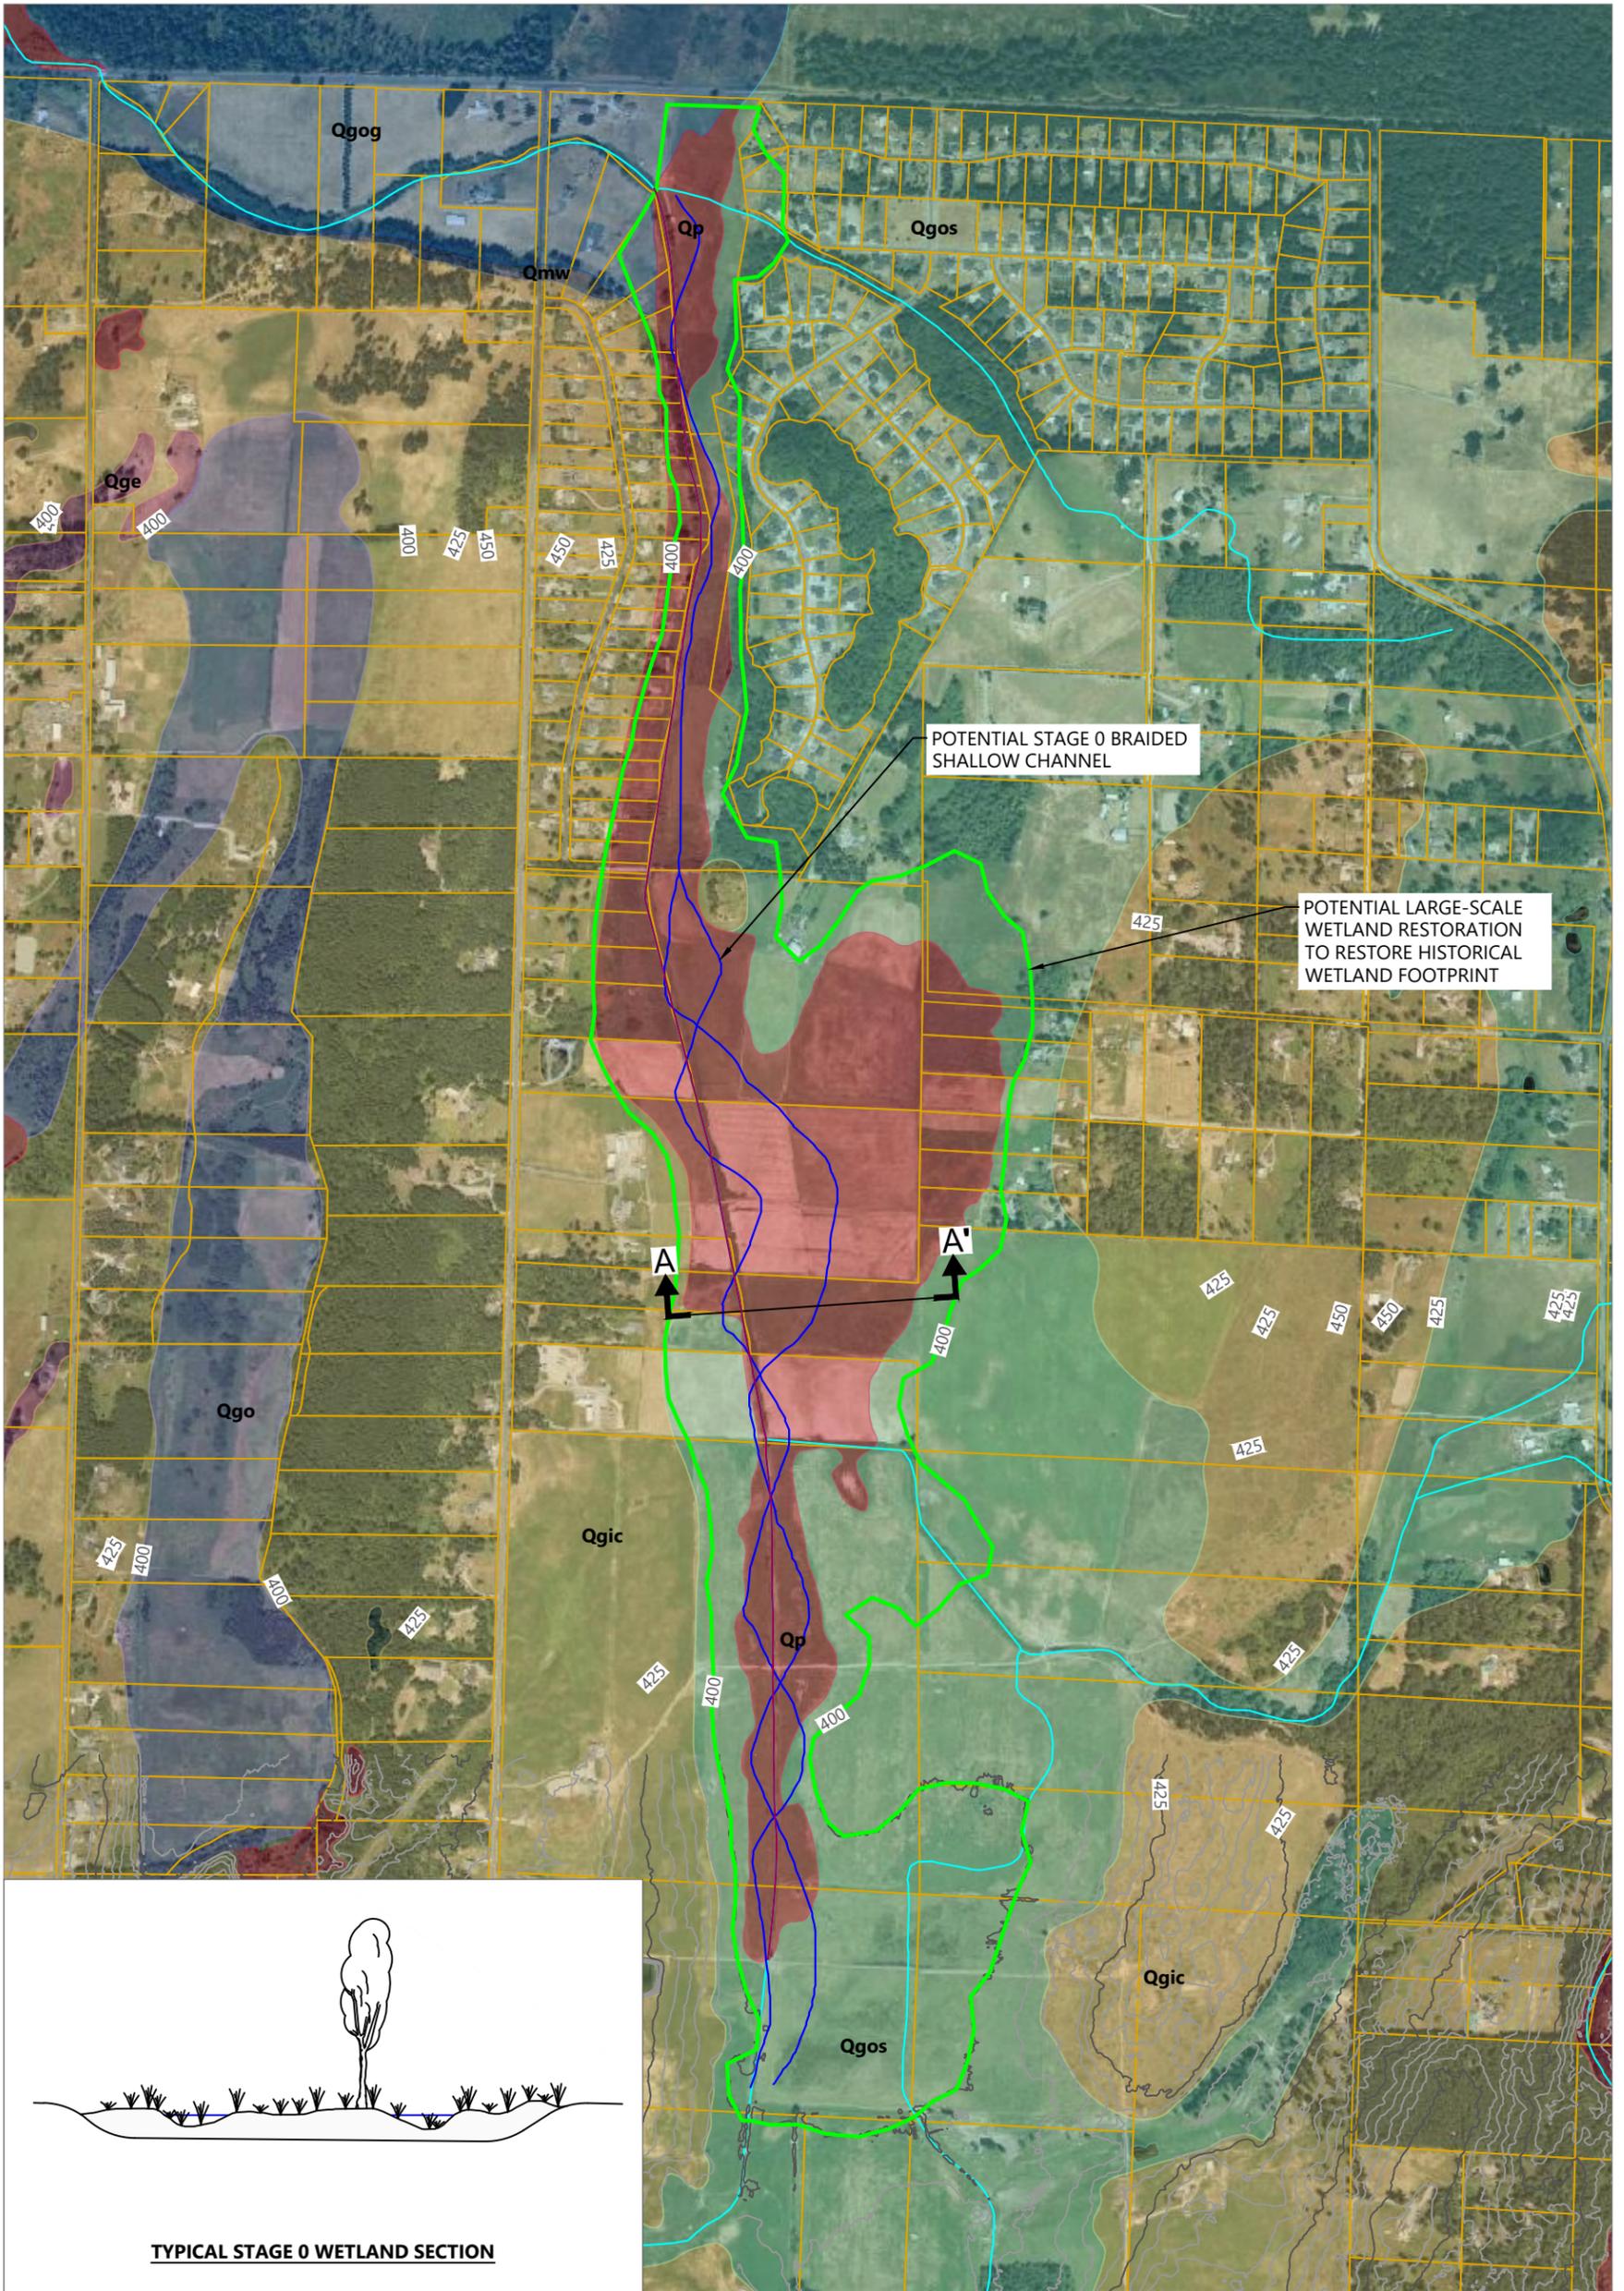
TYPICAL STAGE 0 WETLAND SECTION
